US-411

An Archaeological Process

LANE ADDITIONS TO SR 25 (US 411) FROM TURKEYTOWN IN ETOWAH COUNTY
TO .65 MILES NORTH OF COUNTY ROAD 20, CHEROKEE COUNTY, AL
FEDERAL-AID PROJECT NUMBER STPAA-0137(010)

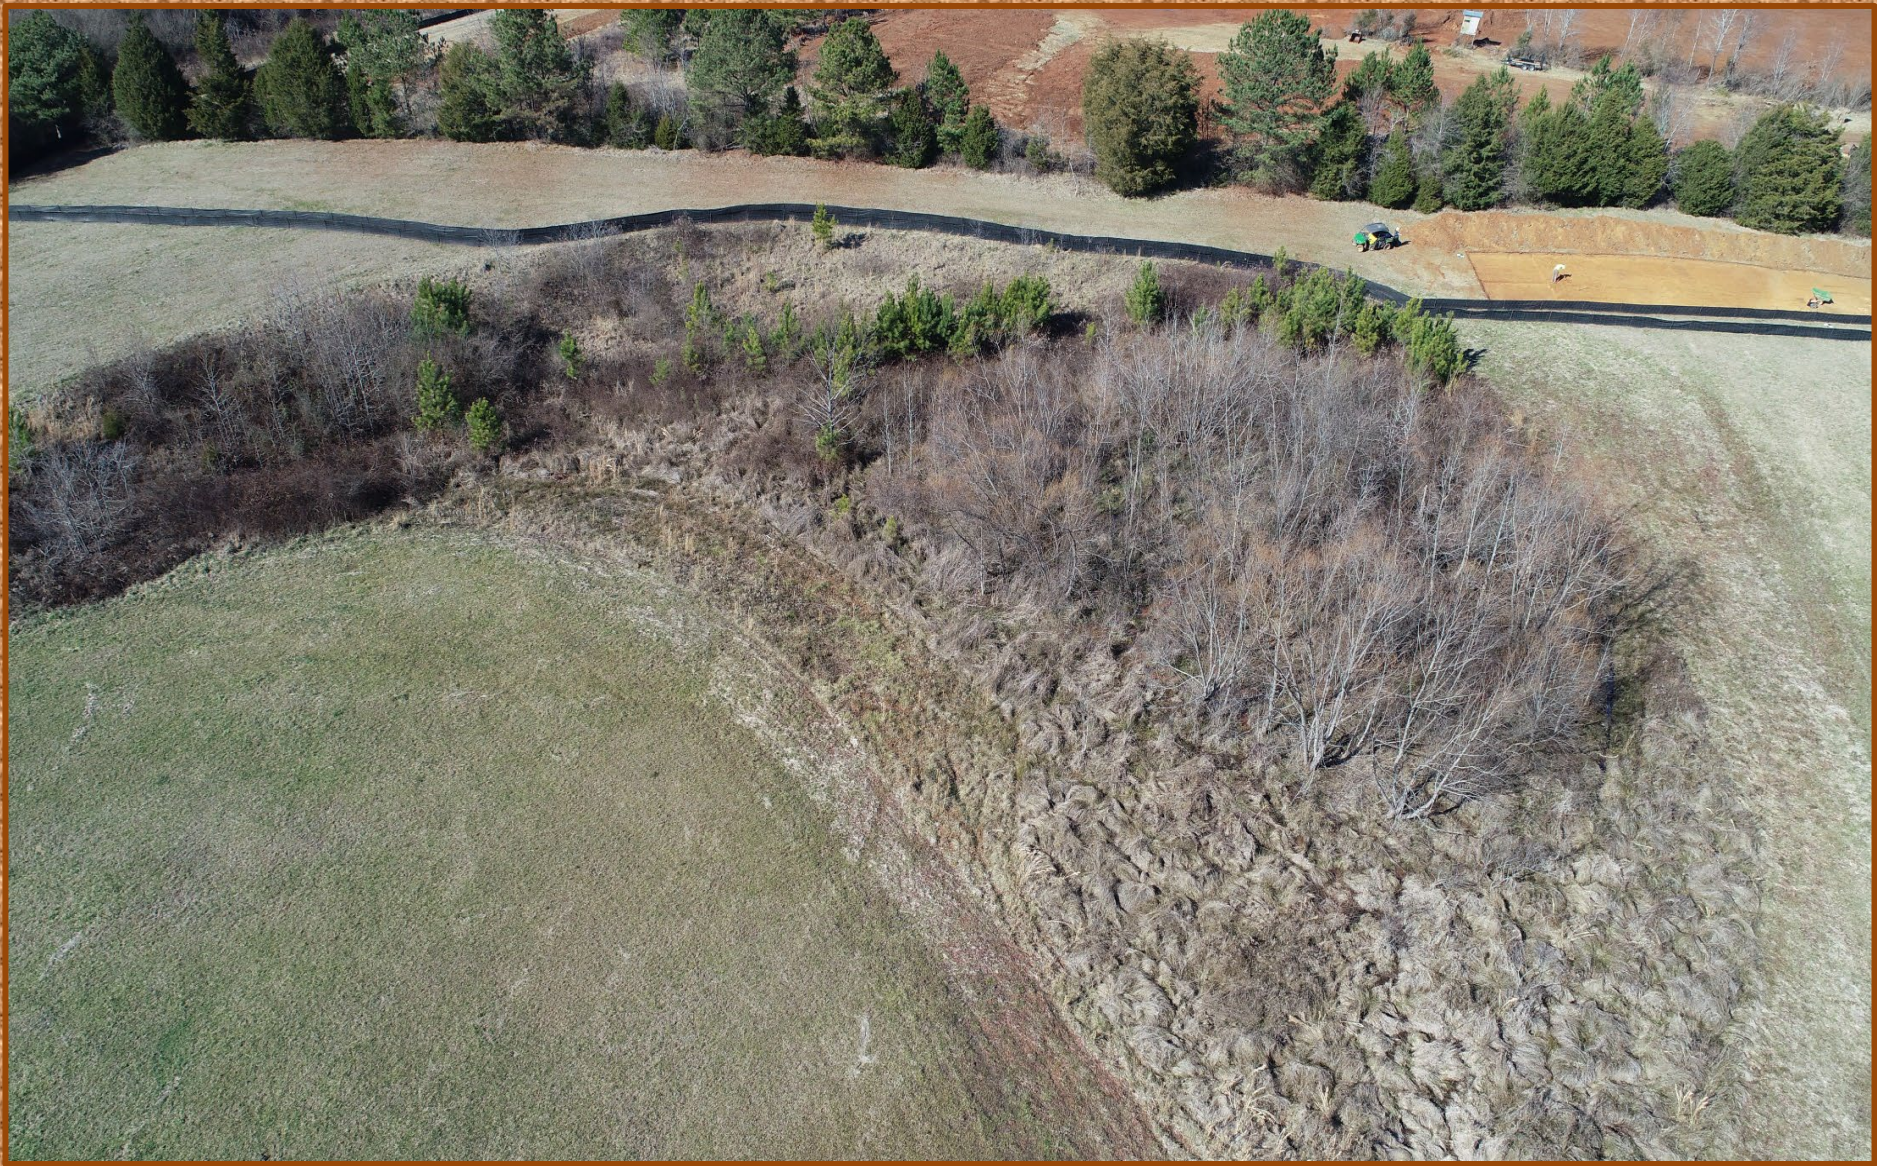
US-411, site 1Et182. Oblique drone view of large karst feature immediately south of project r-o-w limits. Southern r-o-w margin marked by silt fence in background.

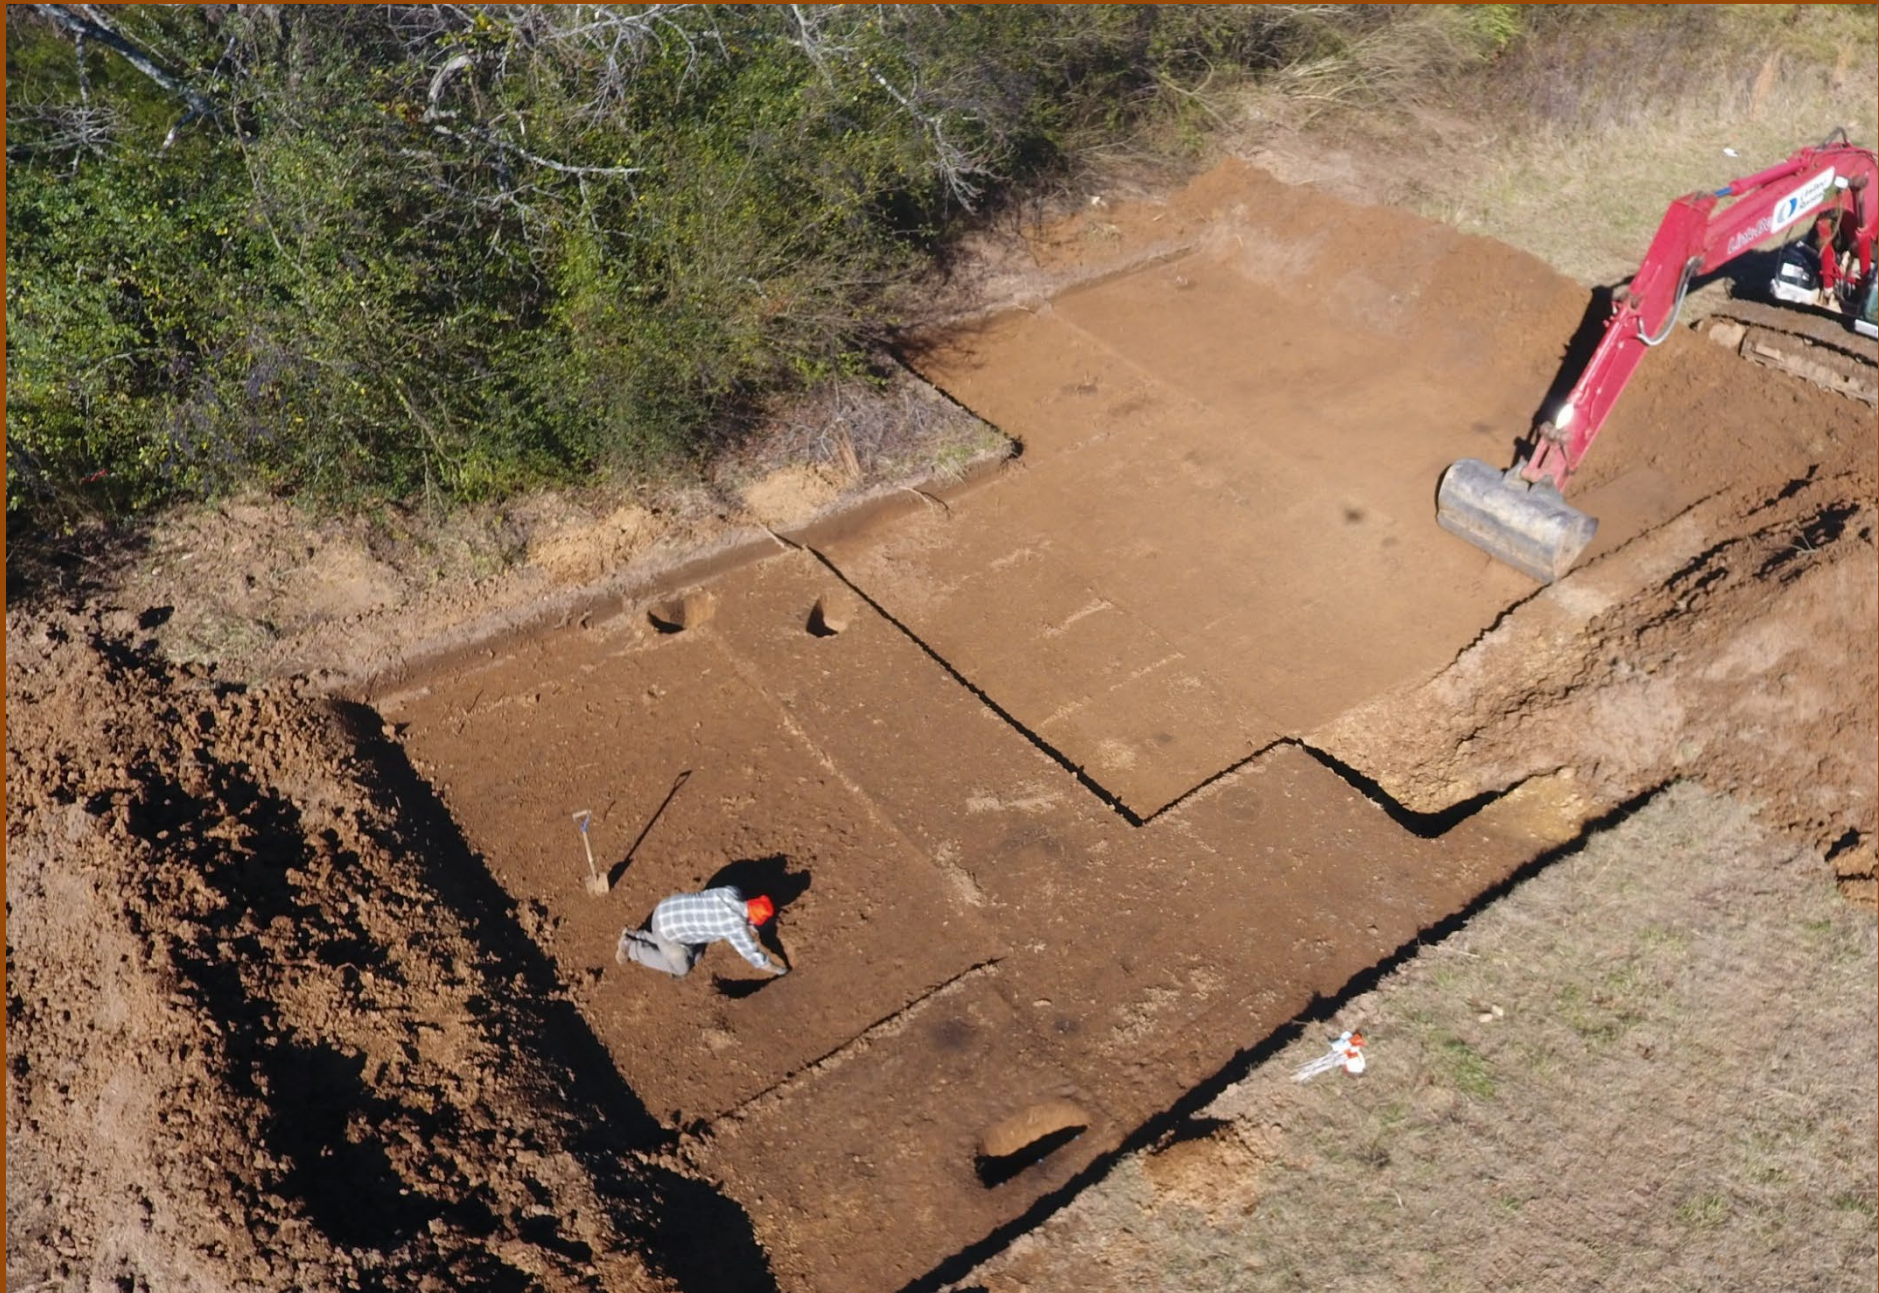
US-411, site 1Et182. General procedure of mechanical plowzone (Ap) removal to expose subsurface cultural features.

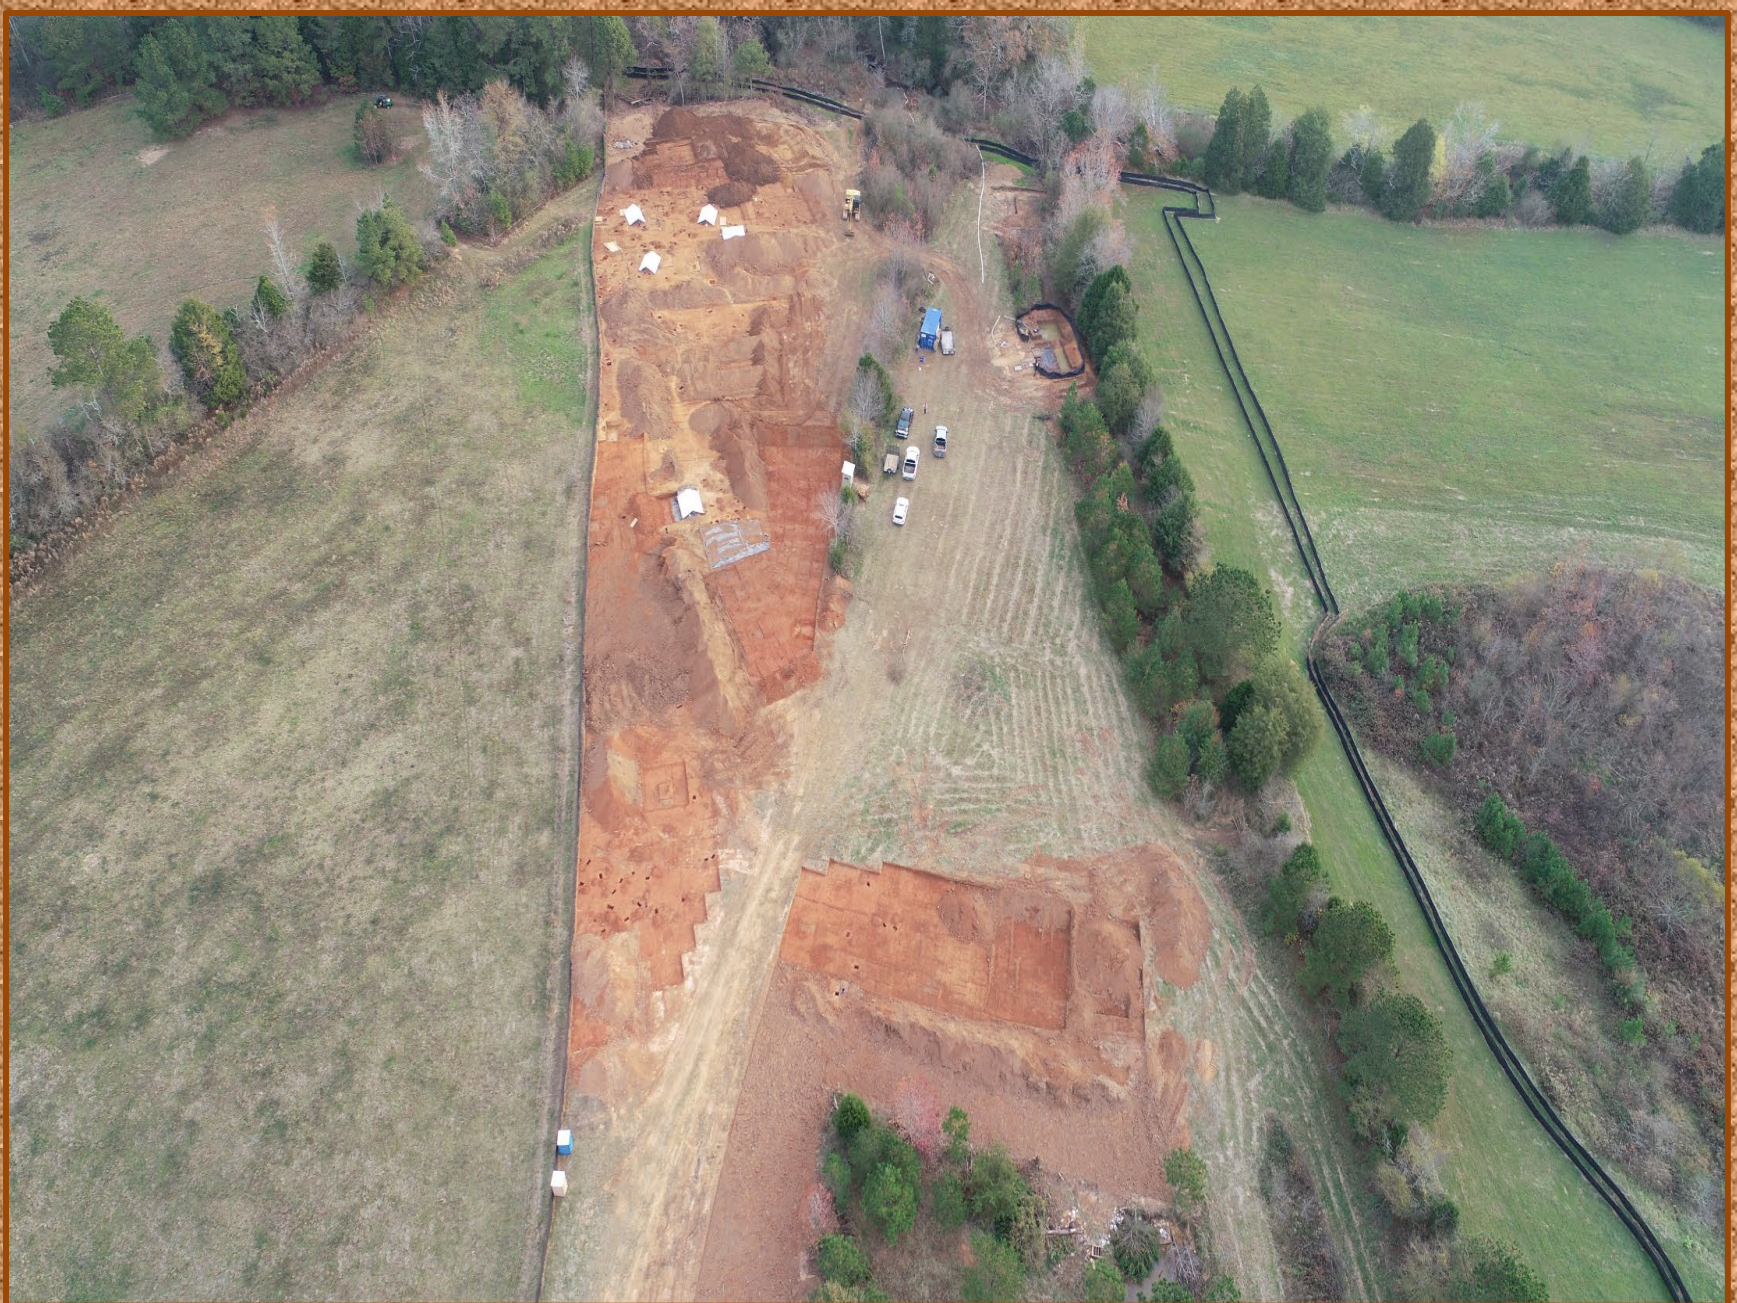
US-431, site 1Et182. Drone view of Phase III Data Recovery in progress. Silt fences mark ~ r-o-w boundaries. View to the NE.

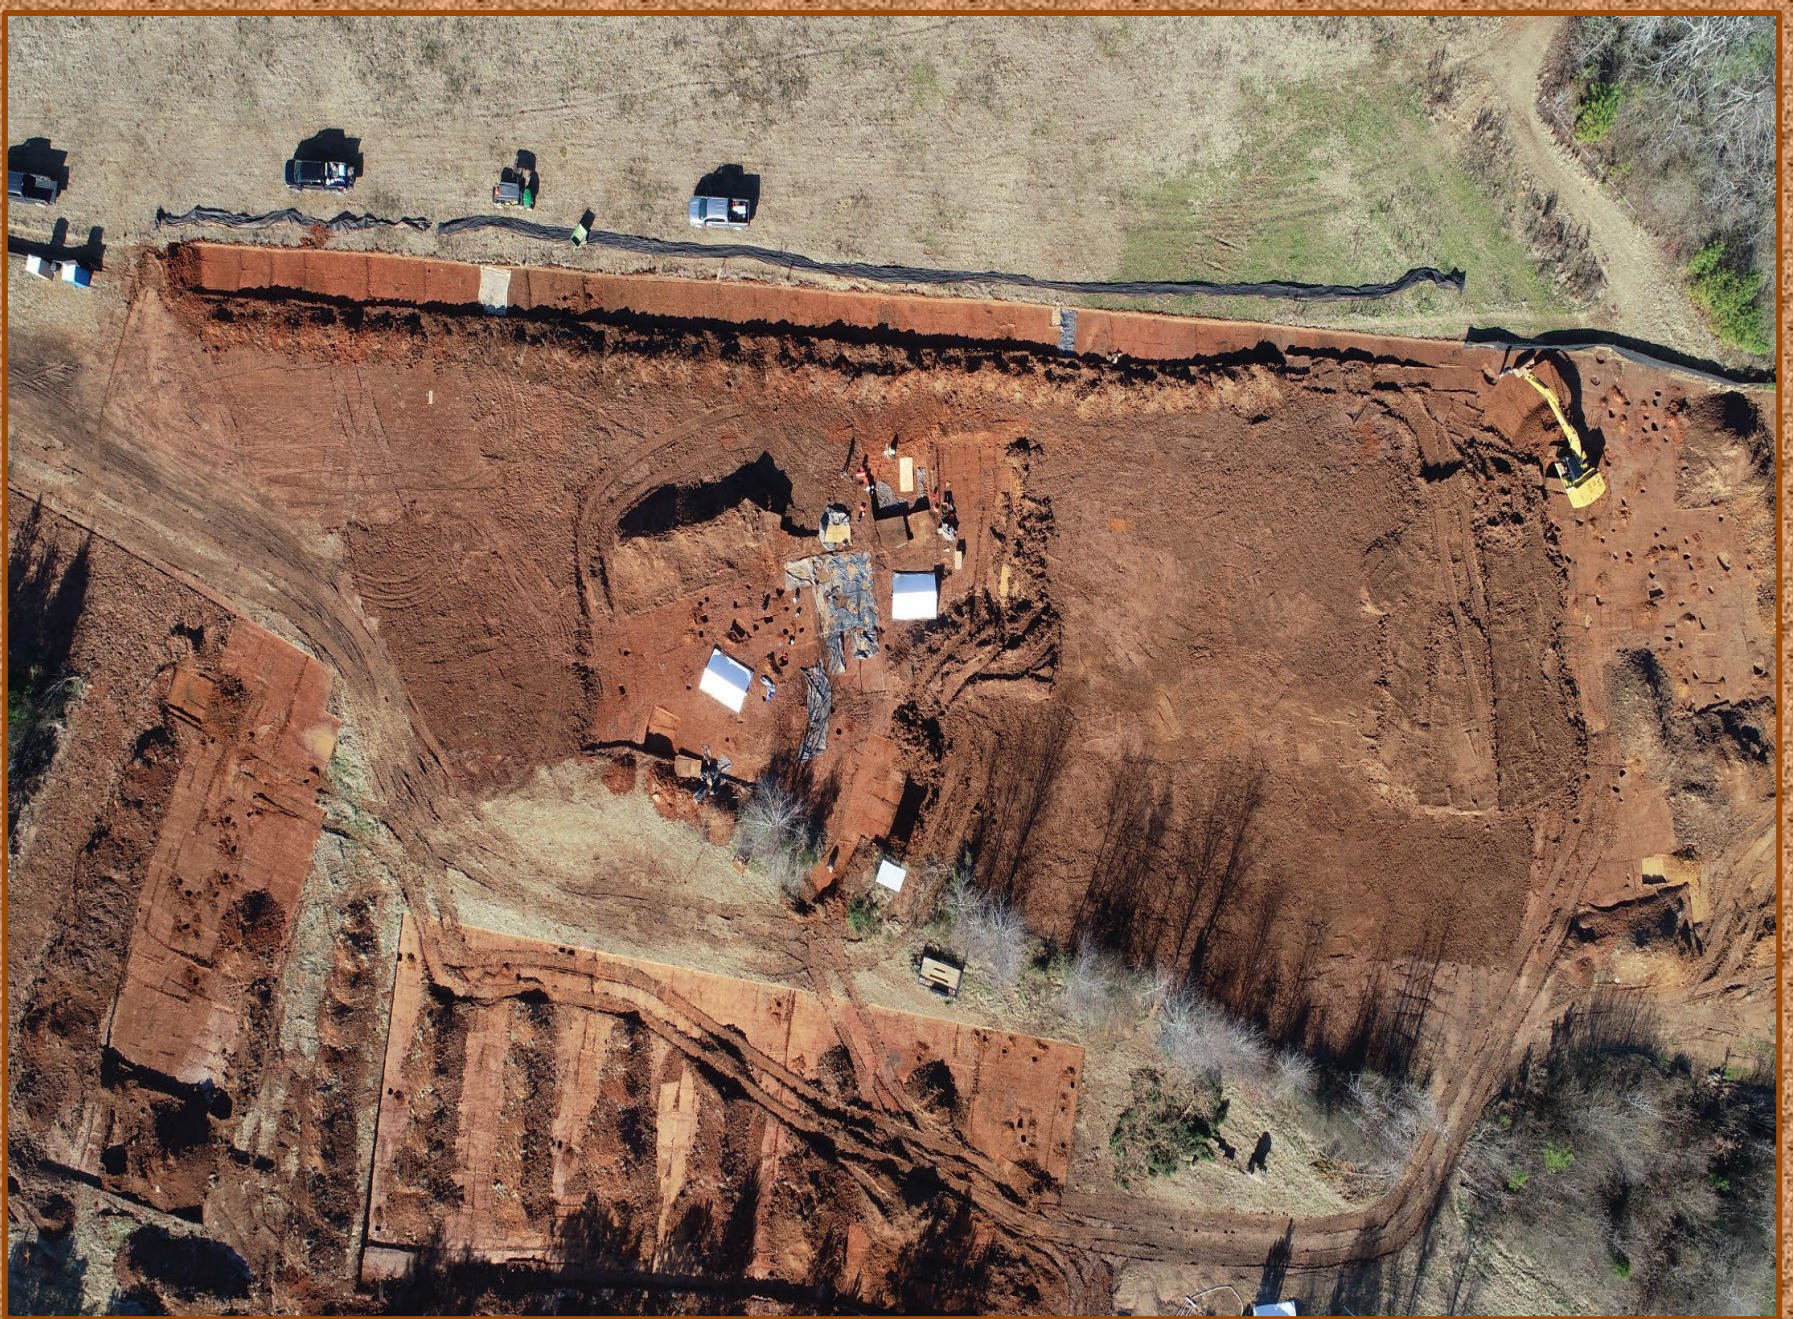
US-411, site 1Et182. Phase III Data Recovery site stripping progress. Plow-disturbed sediment removal along north r-o-w margin.

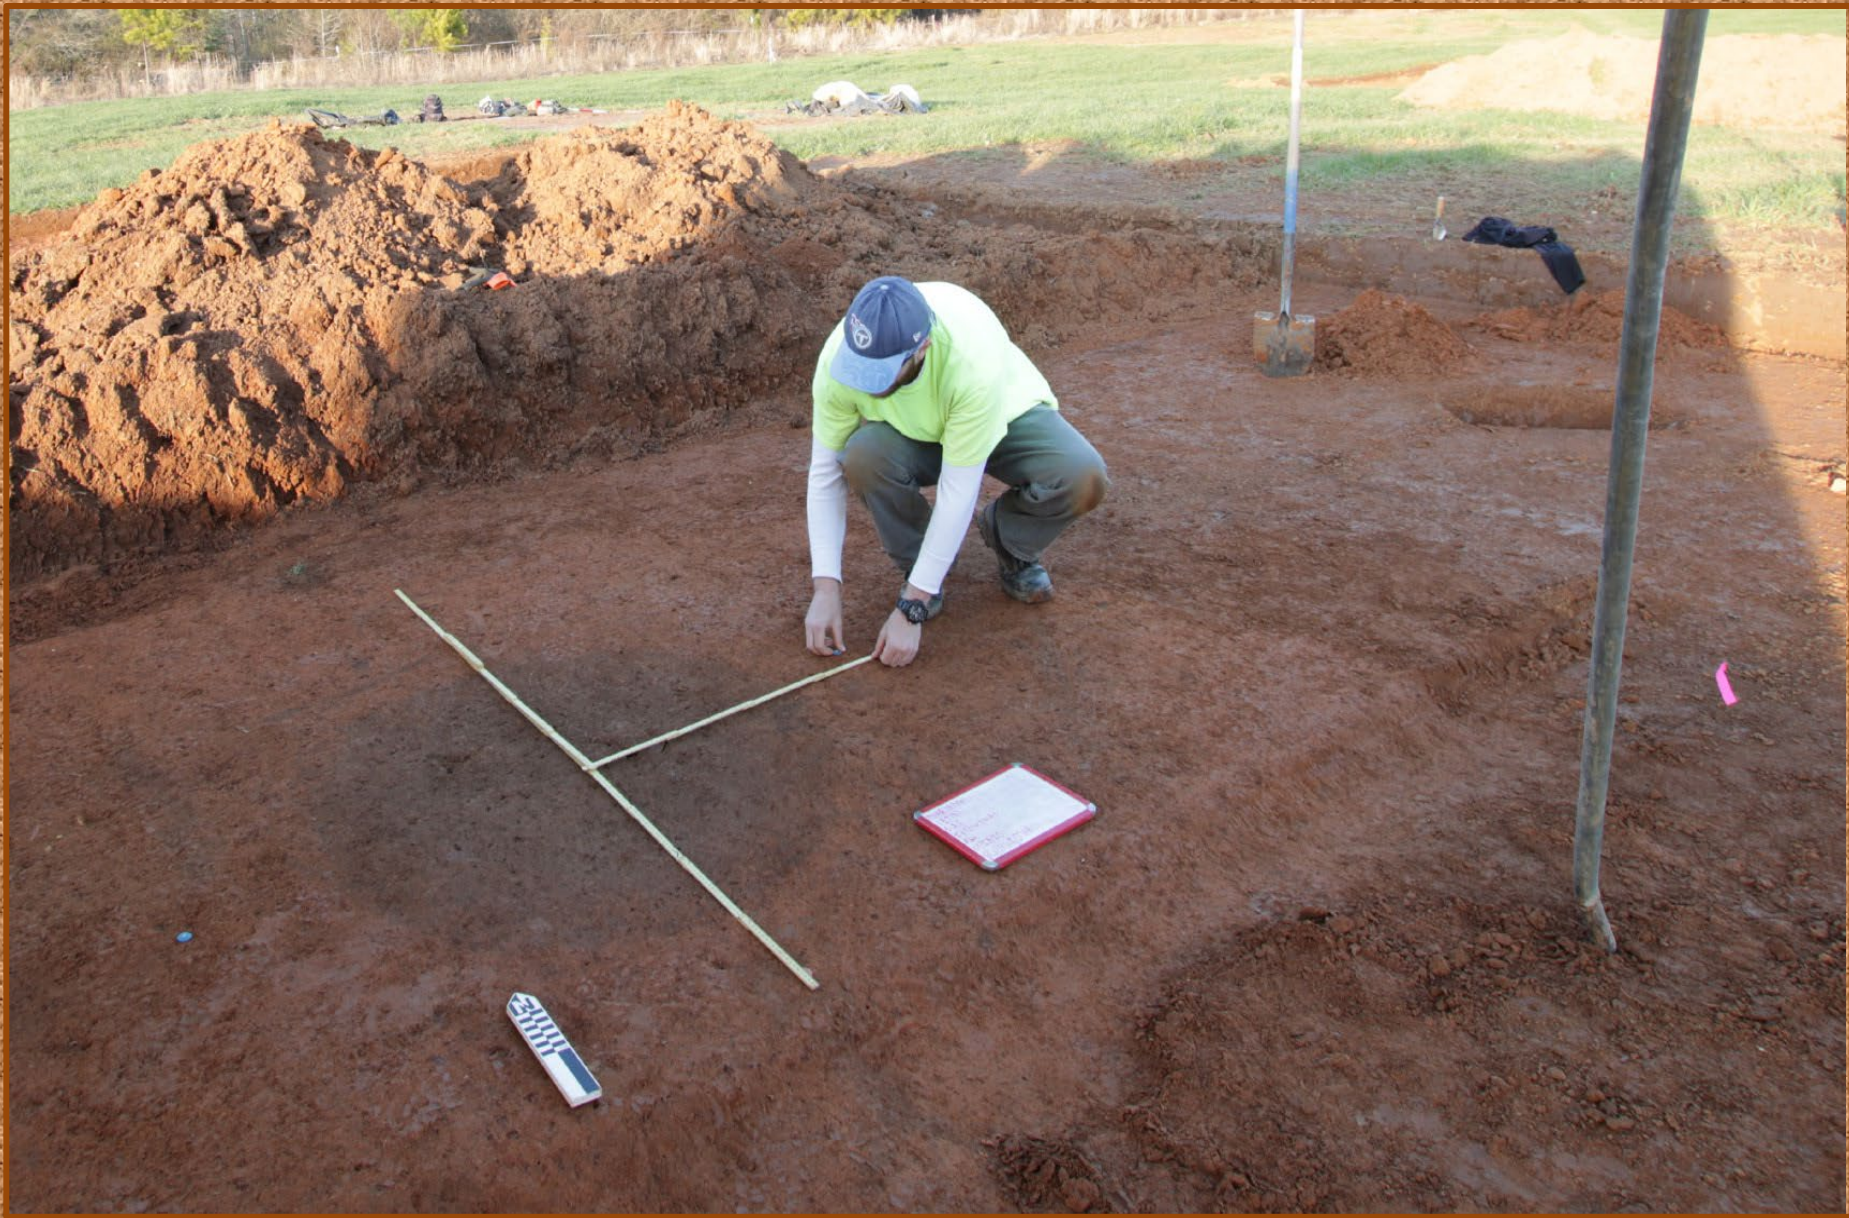
US-411, site 1Et182. Mapping of feature prior to excavation.

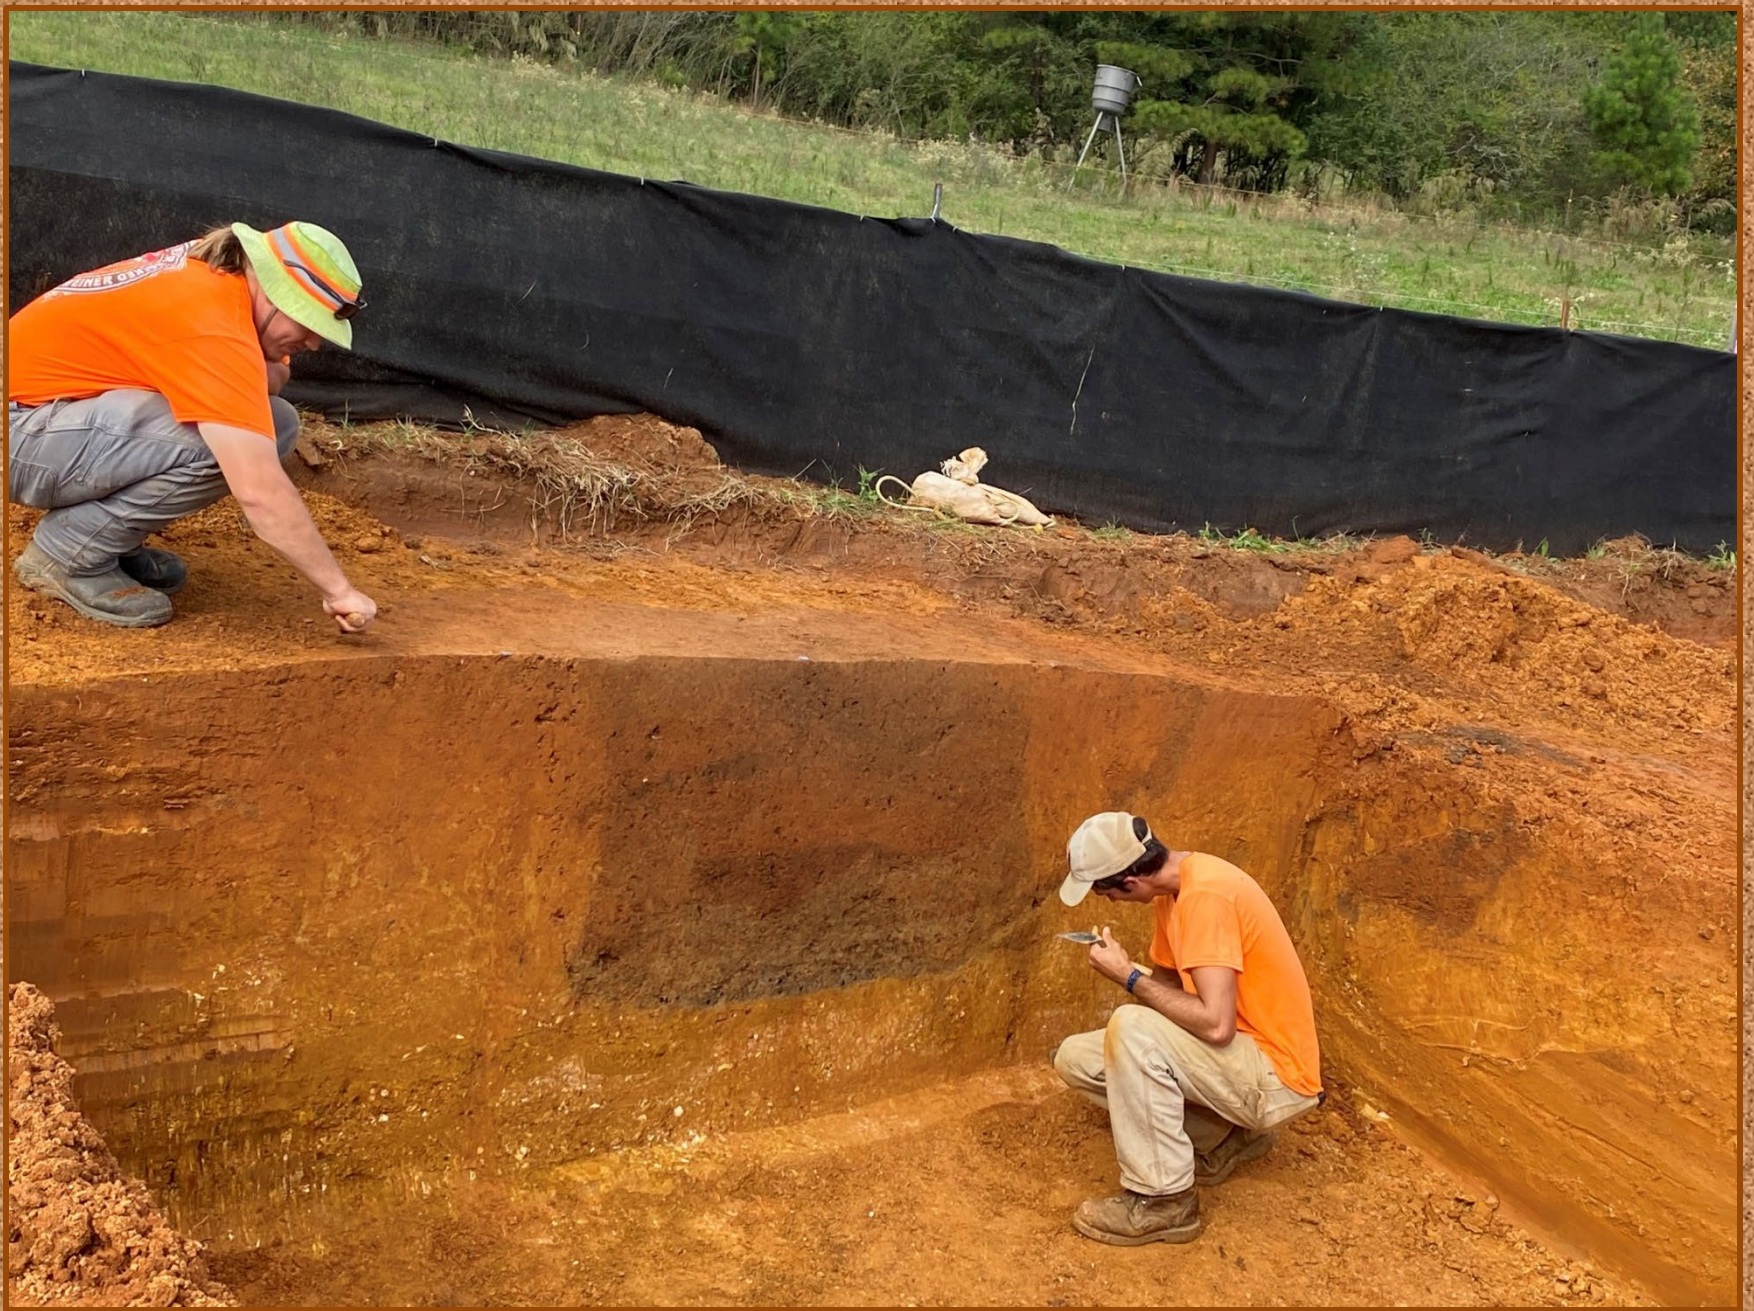
US-411, 1Et182. Final feature profile preparation for photo.

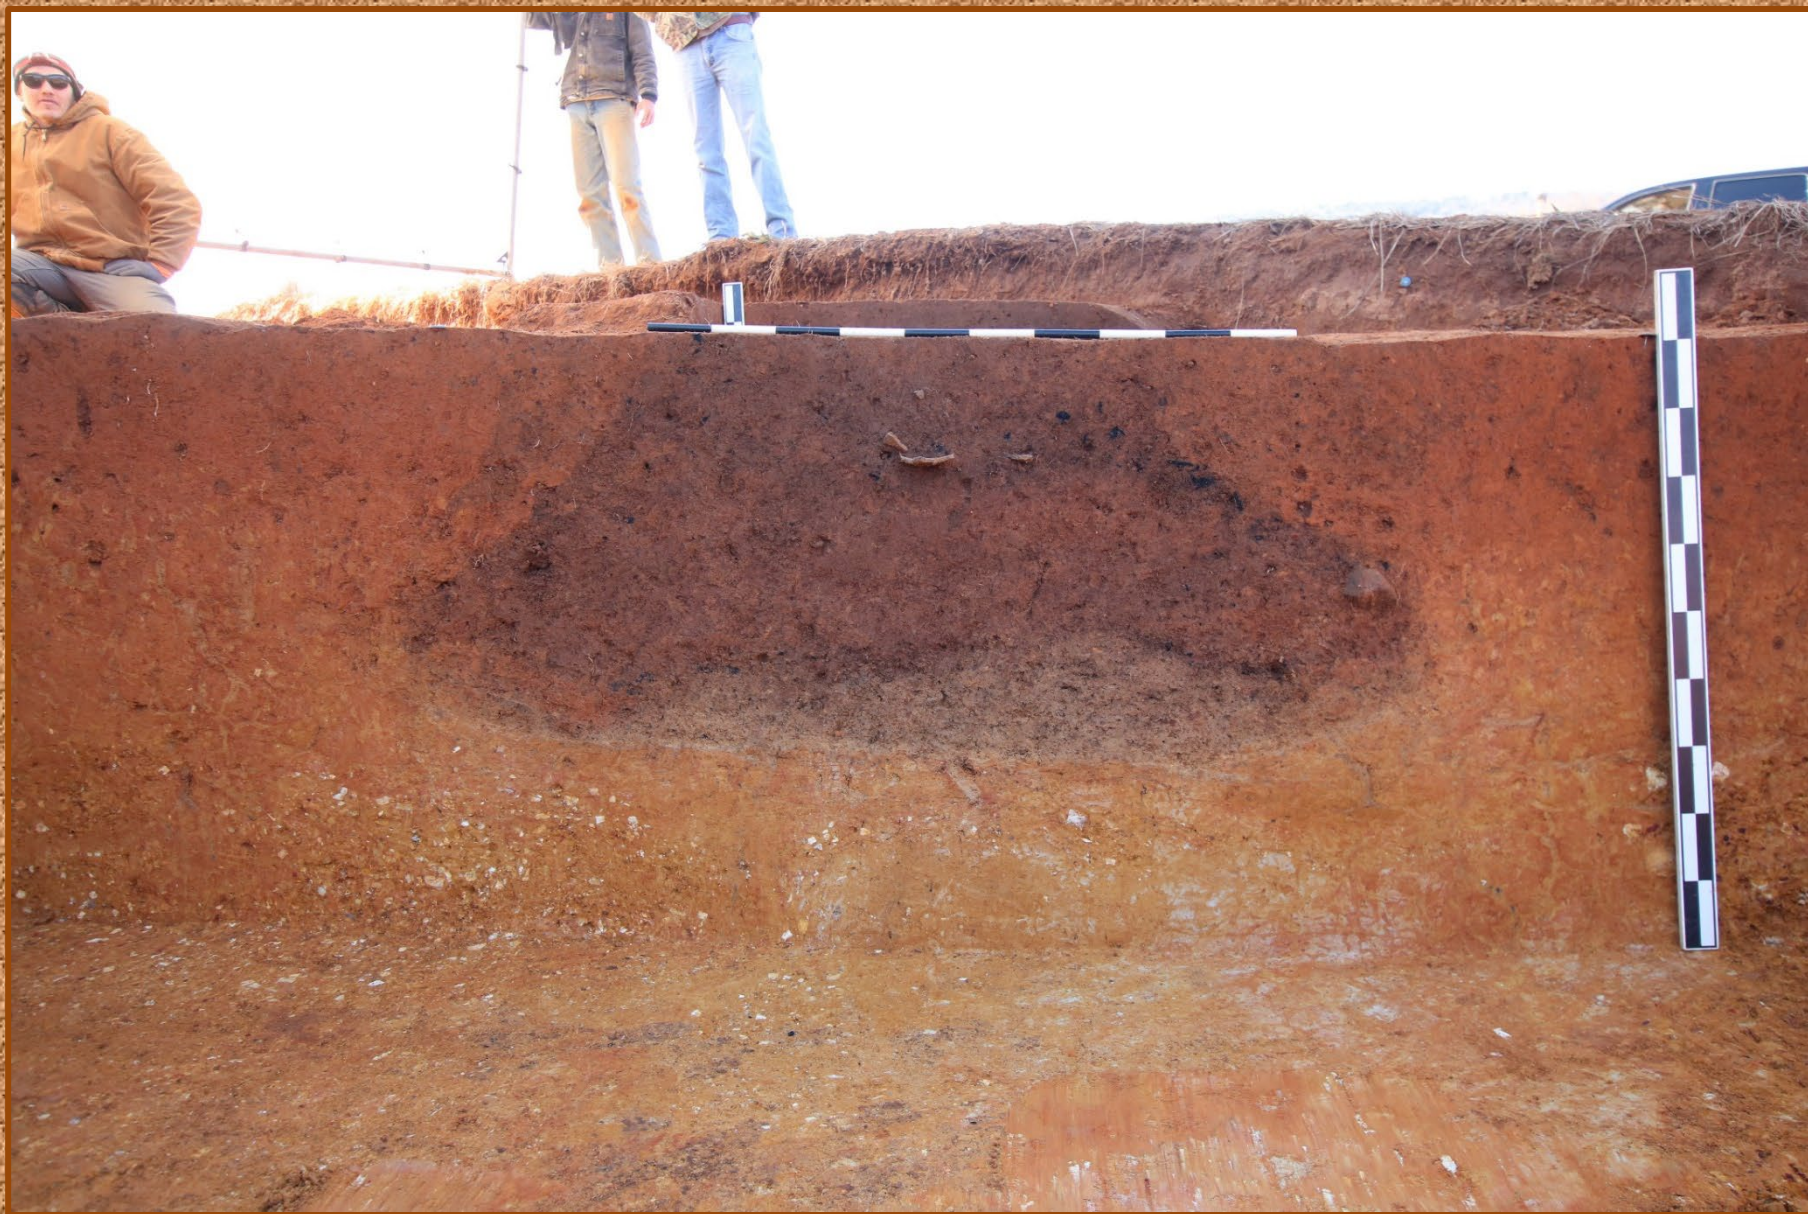
US-411, site 1Et182. Profile view, Late Woodland bell-shaped pit (Feature 179)

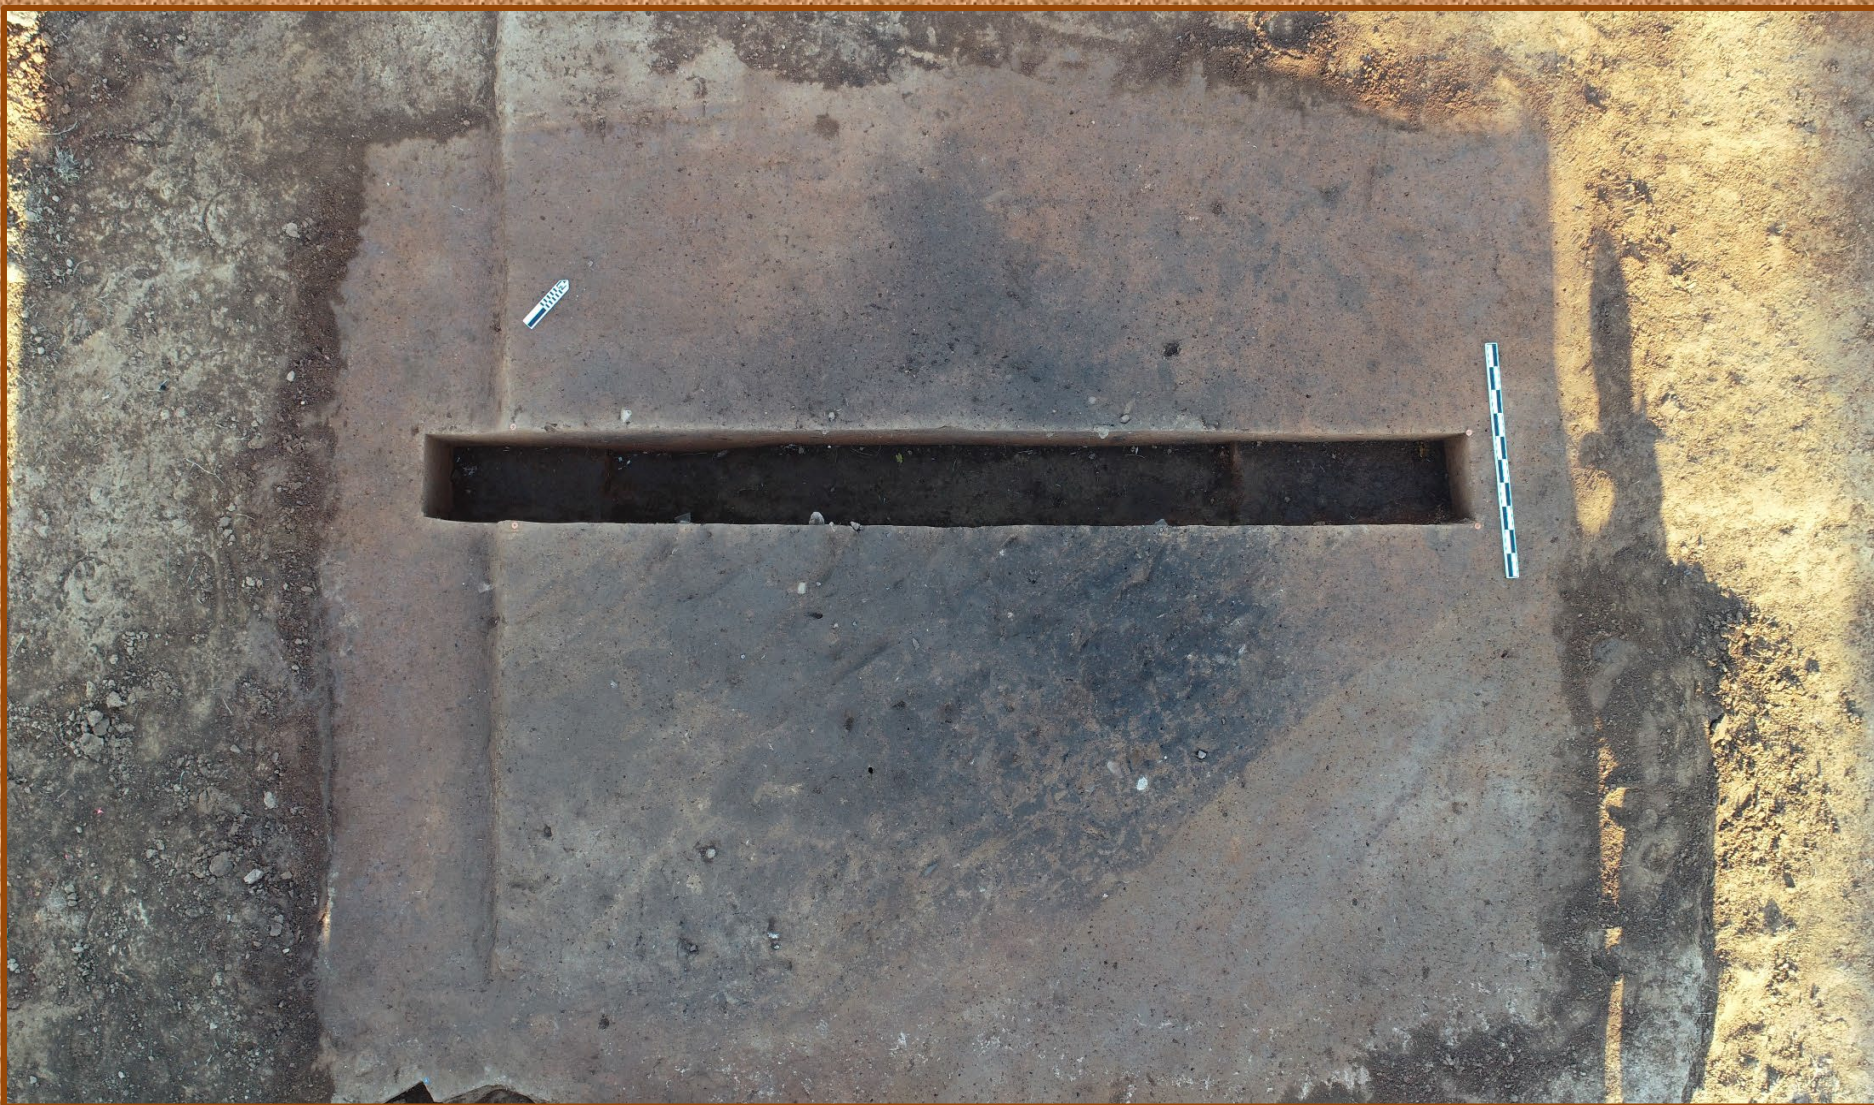
US 411, site 1Et182. Drone view of Feature 73 showing stratigraphic trench bisecting cultural deposits.

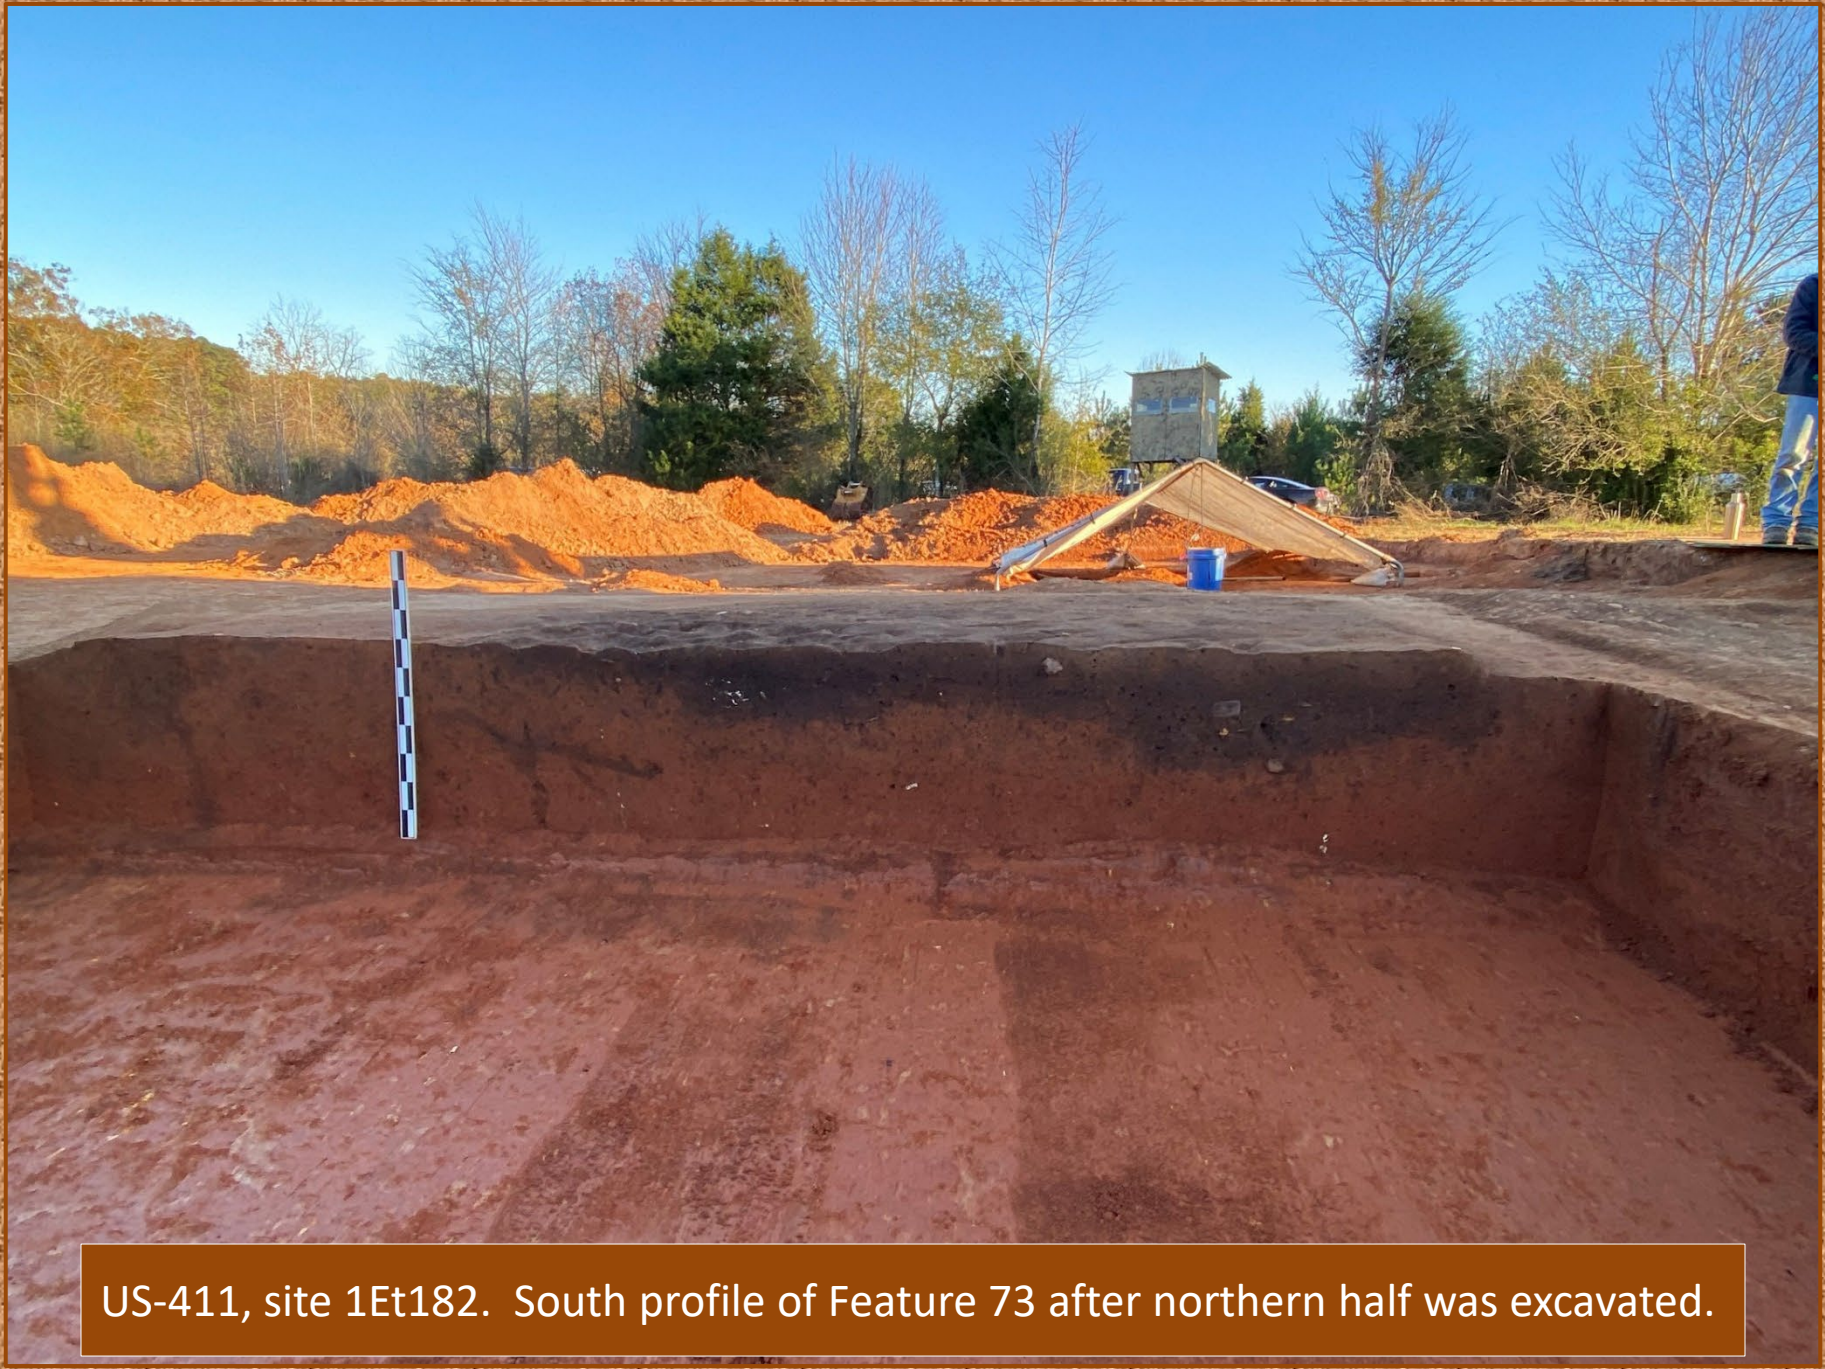
US-411, site 1Et182. South profile of Feature 73 after northern half was excavated.

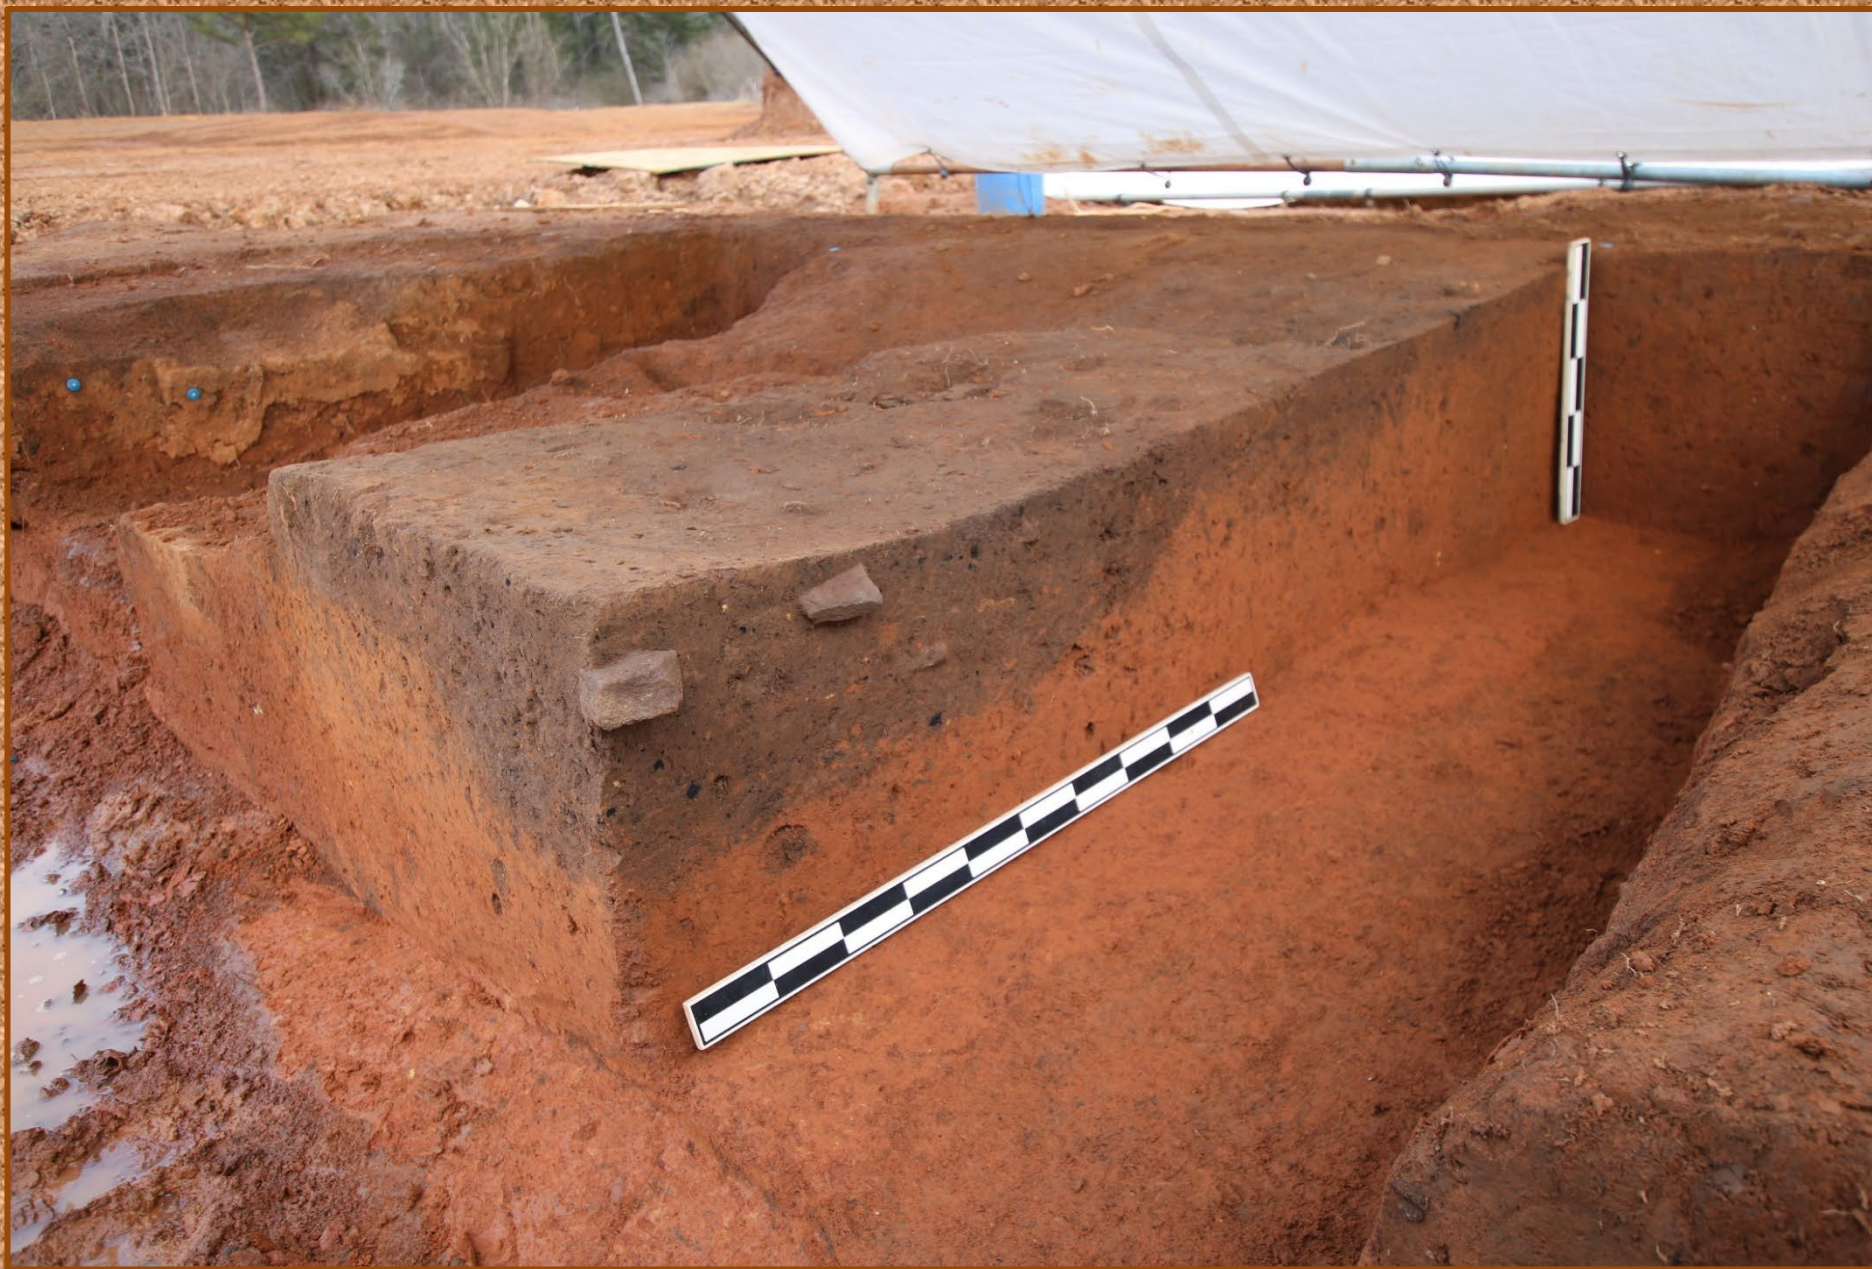
US-411, 1Et182. Feature profile exposure prior to final stratigraphic excavation.
