US-411

An Archaeological Process

LANE ADDITIONS TO SR 25 (US 411) FROM TURKEYTOWN IN ETOWAH COUNTY
TO .65 MILES NORTH OF COUNTY ROAD 20, CHEROKEE COUNTY, AL
FEDERAL-AID PROJECT NUMBER STPAA-0137(010)

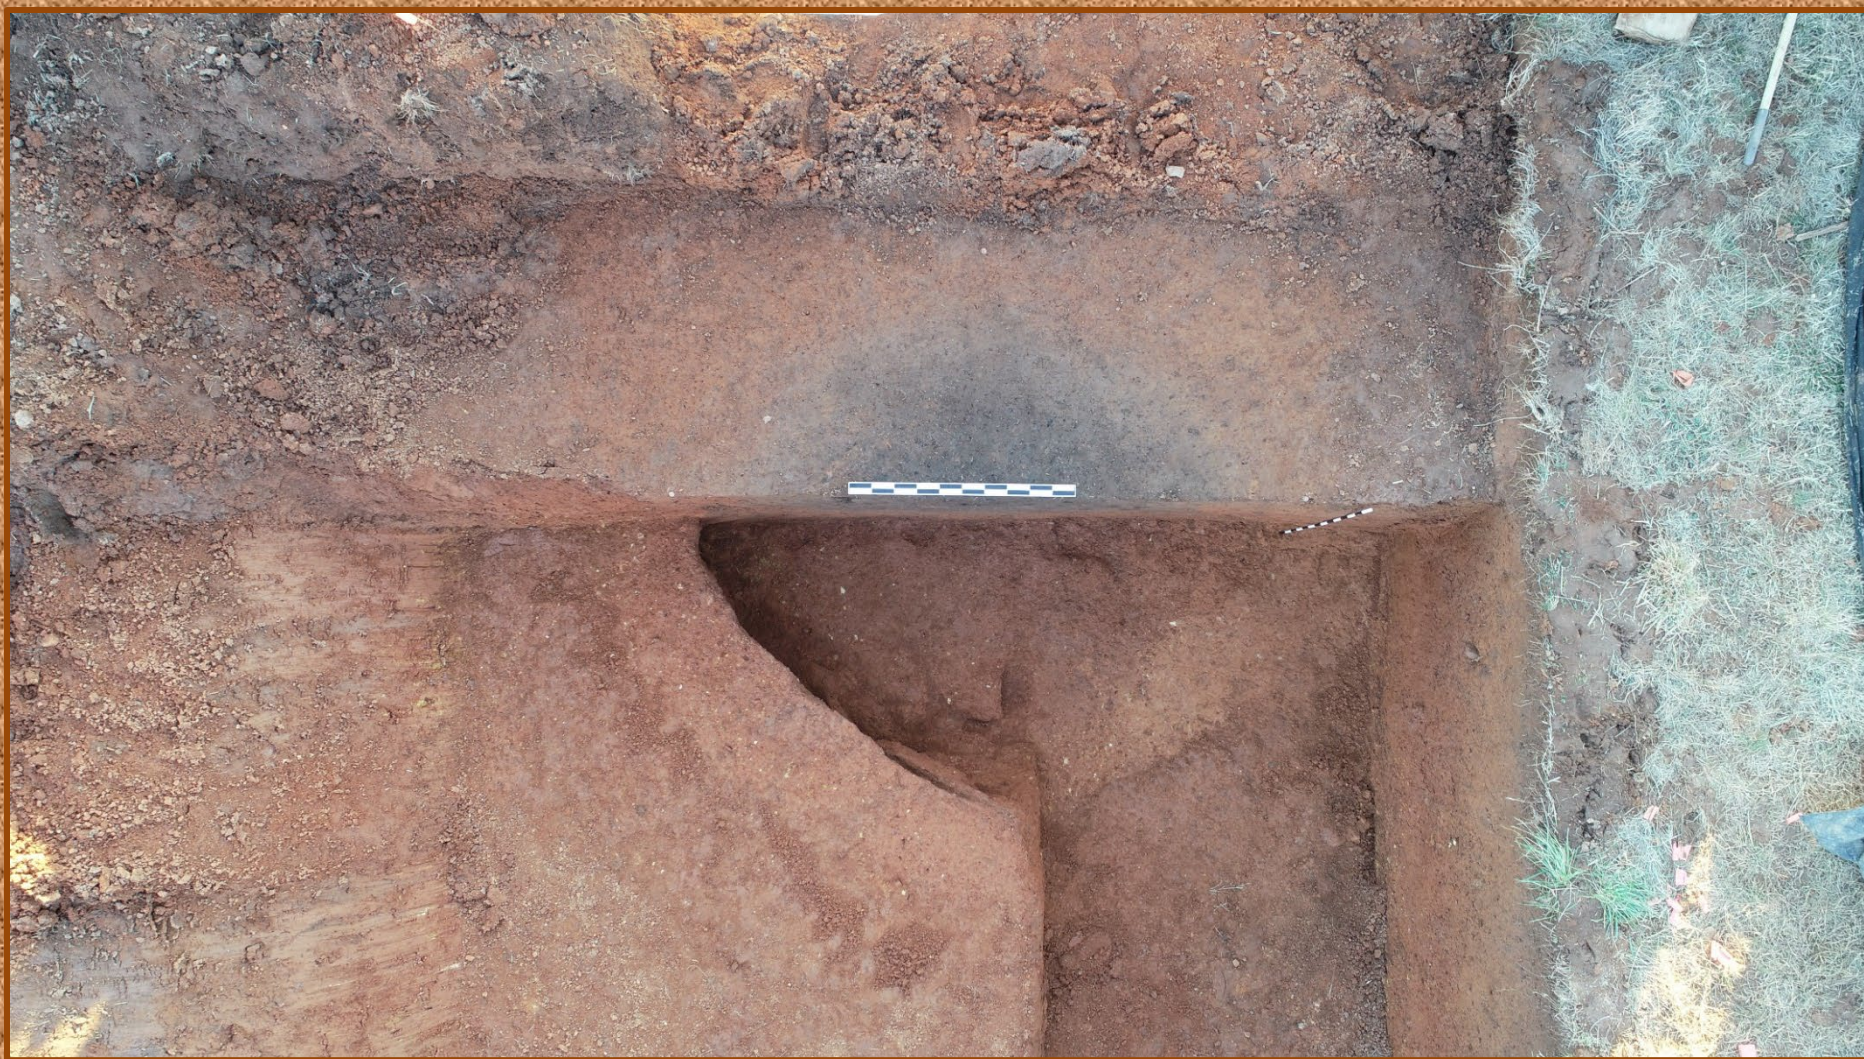
US 411, 1Et182. Drone view of Feature 201 early stages of excavation.

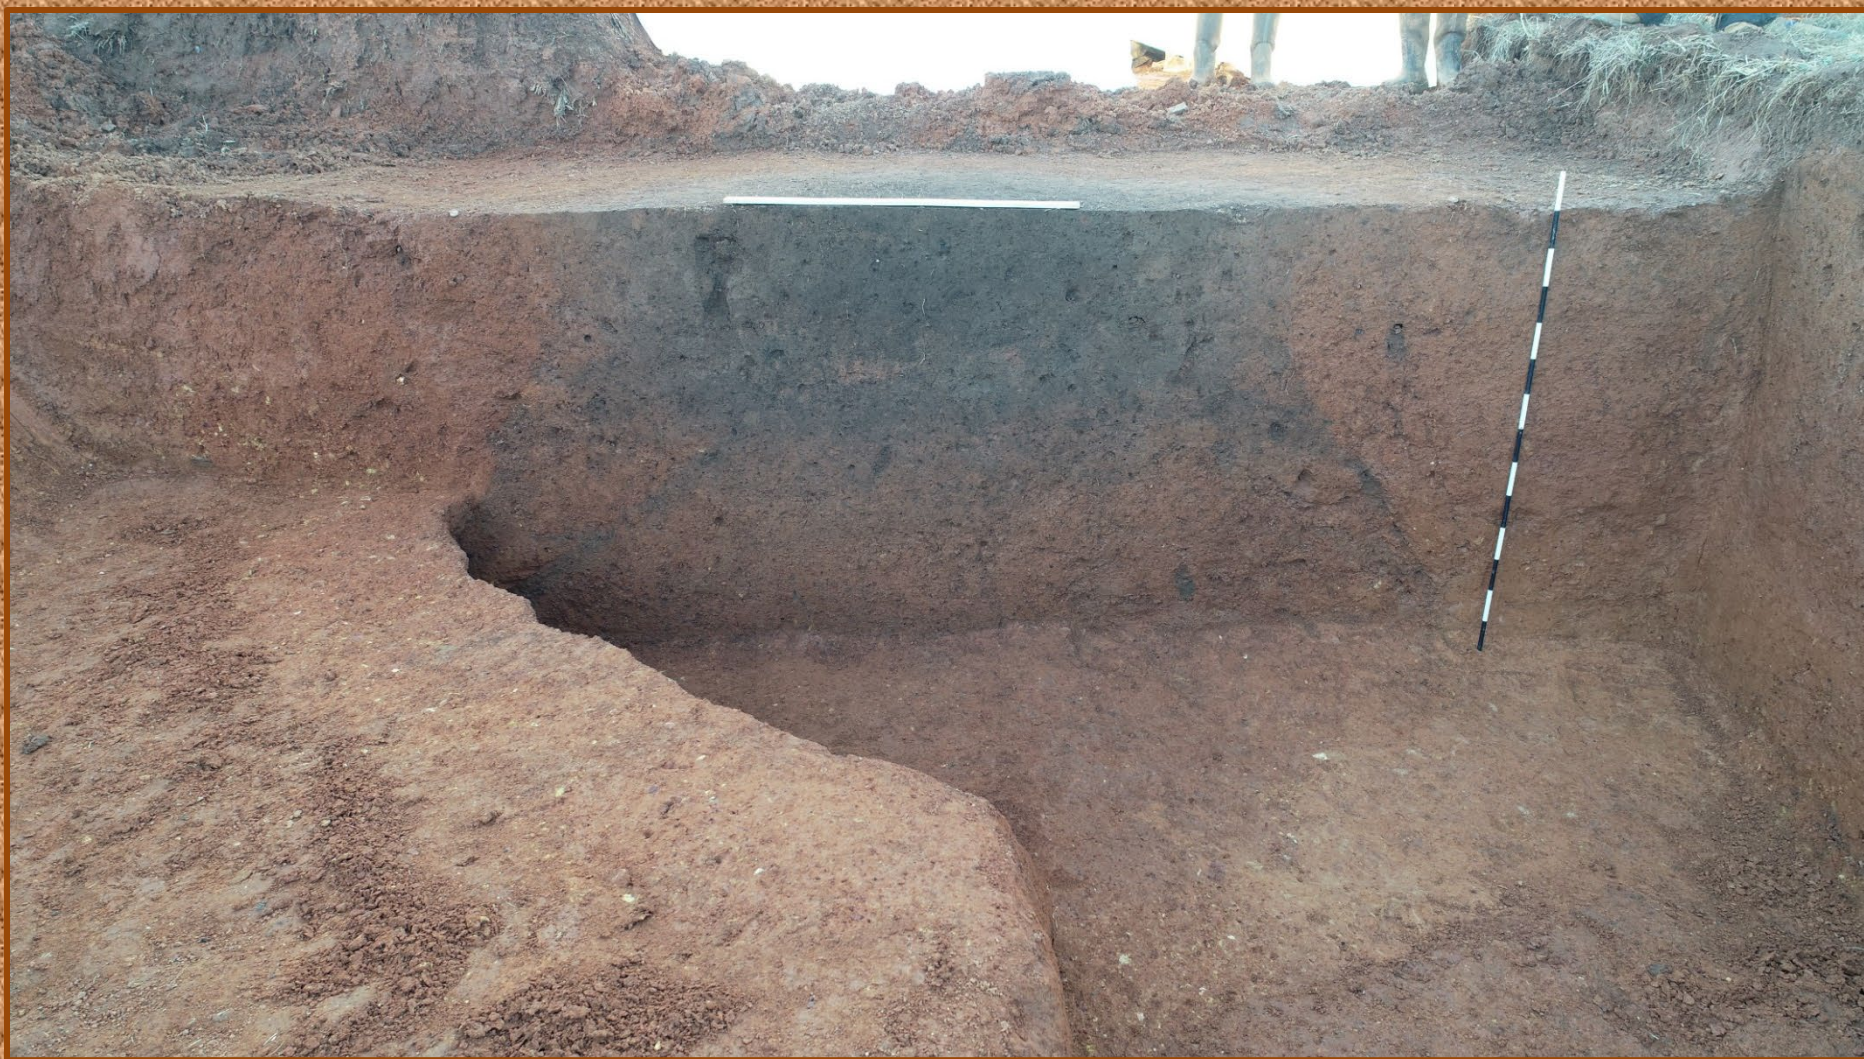
US 411, 1Et182. Profile of Feature 201 during early stages of excavation.

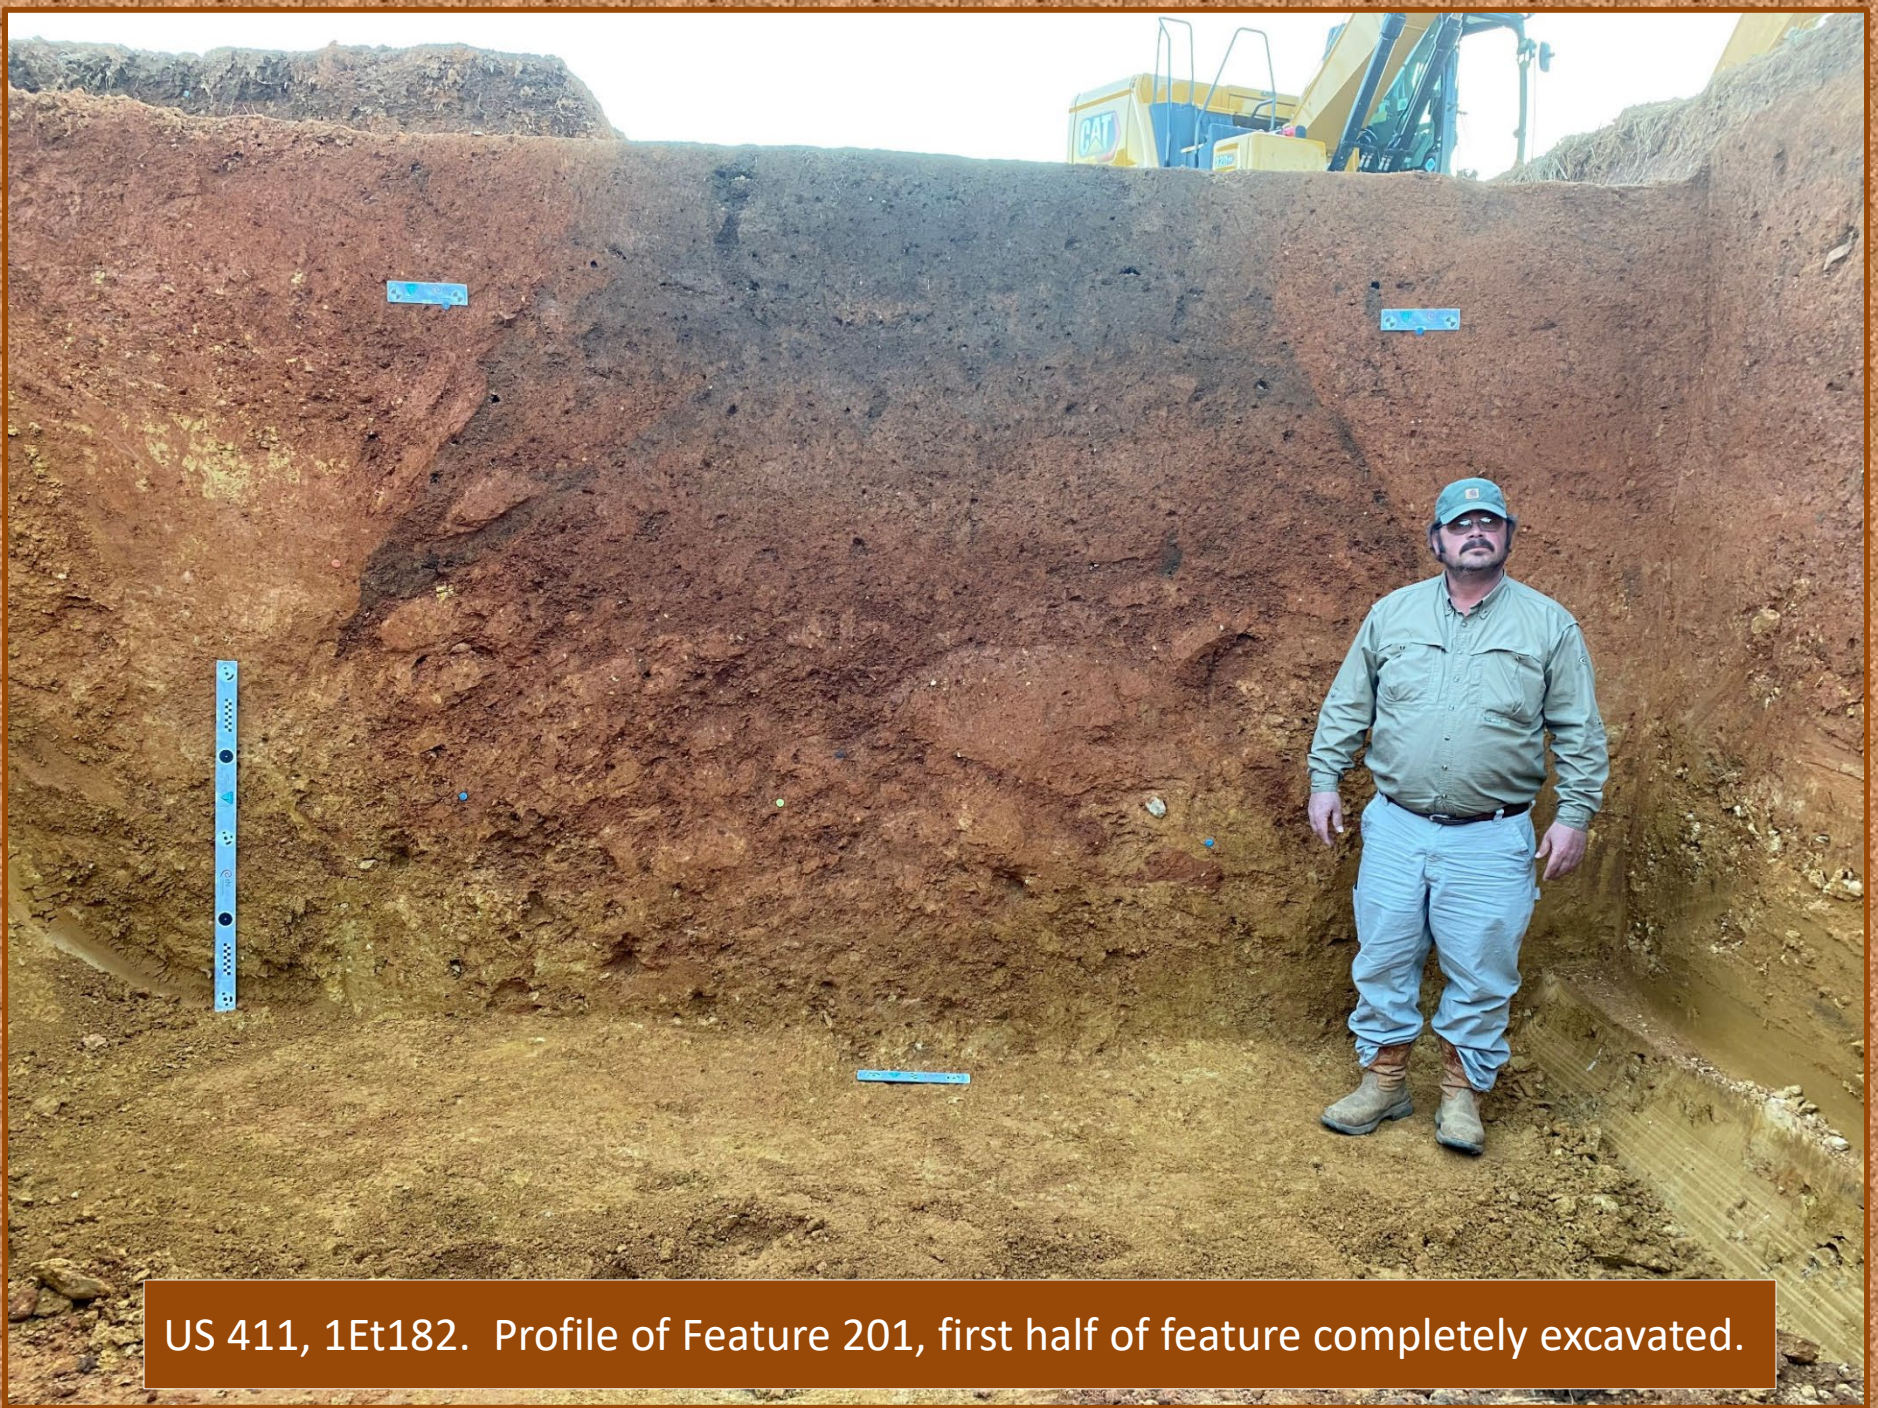
US 411, 1Et182. Profile of Feature 201, first half of feature completely excavated.

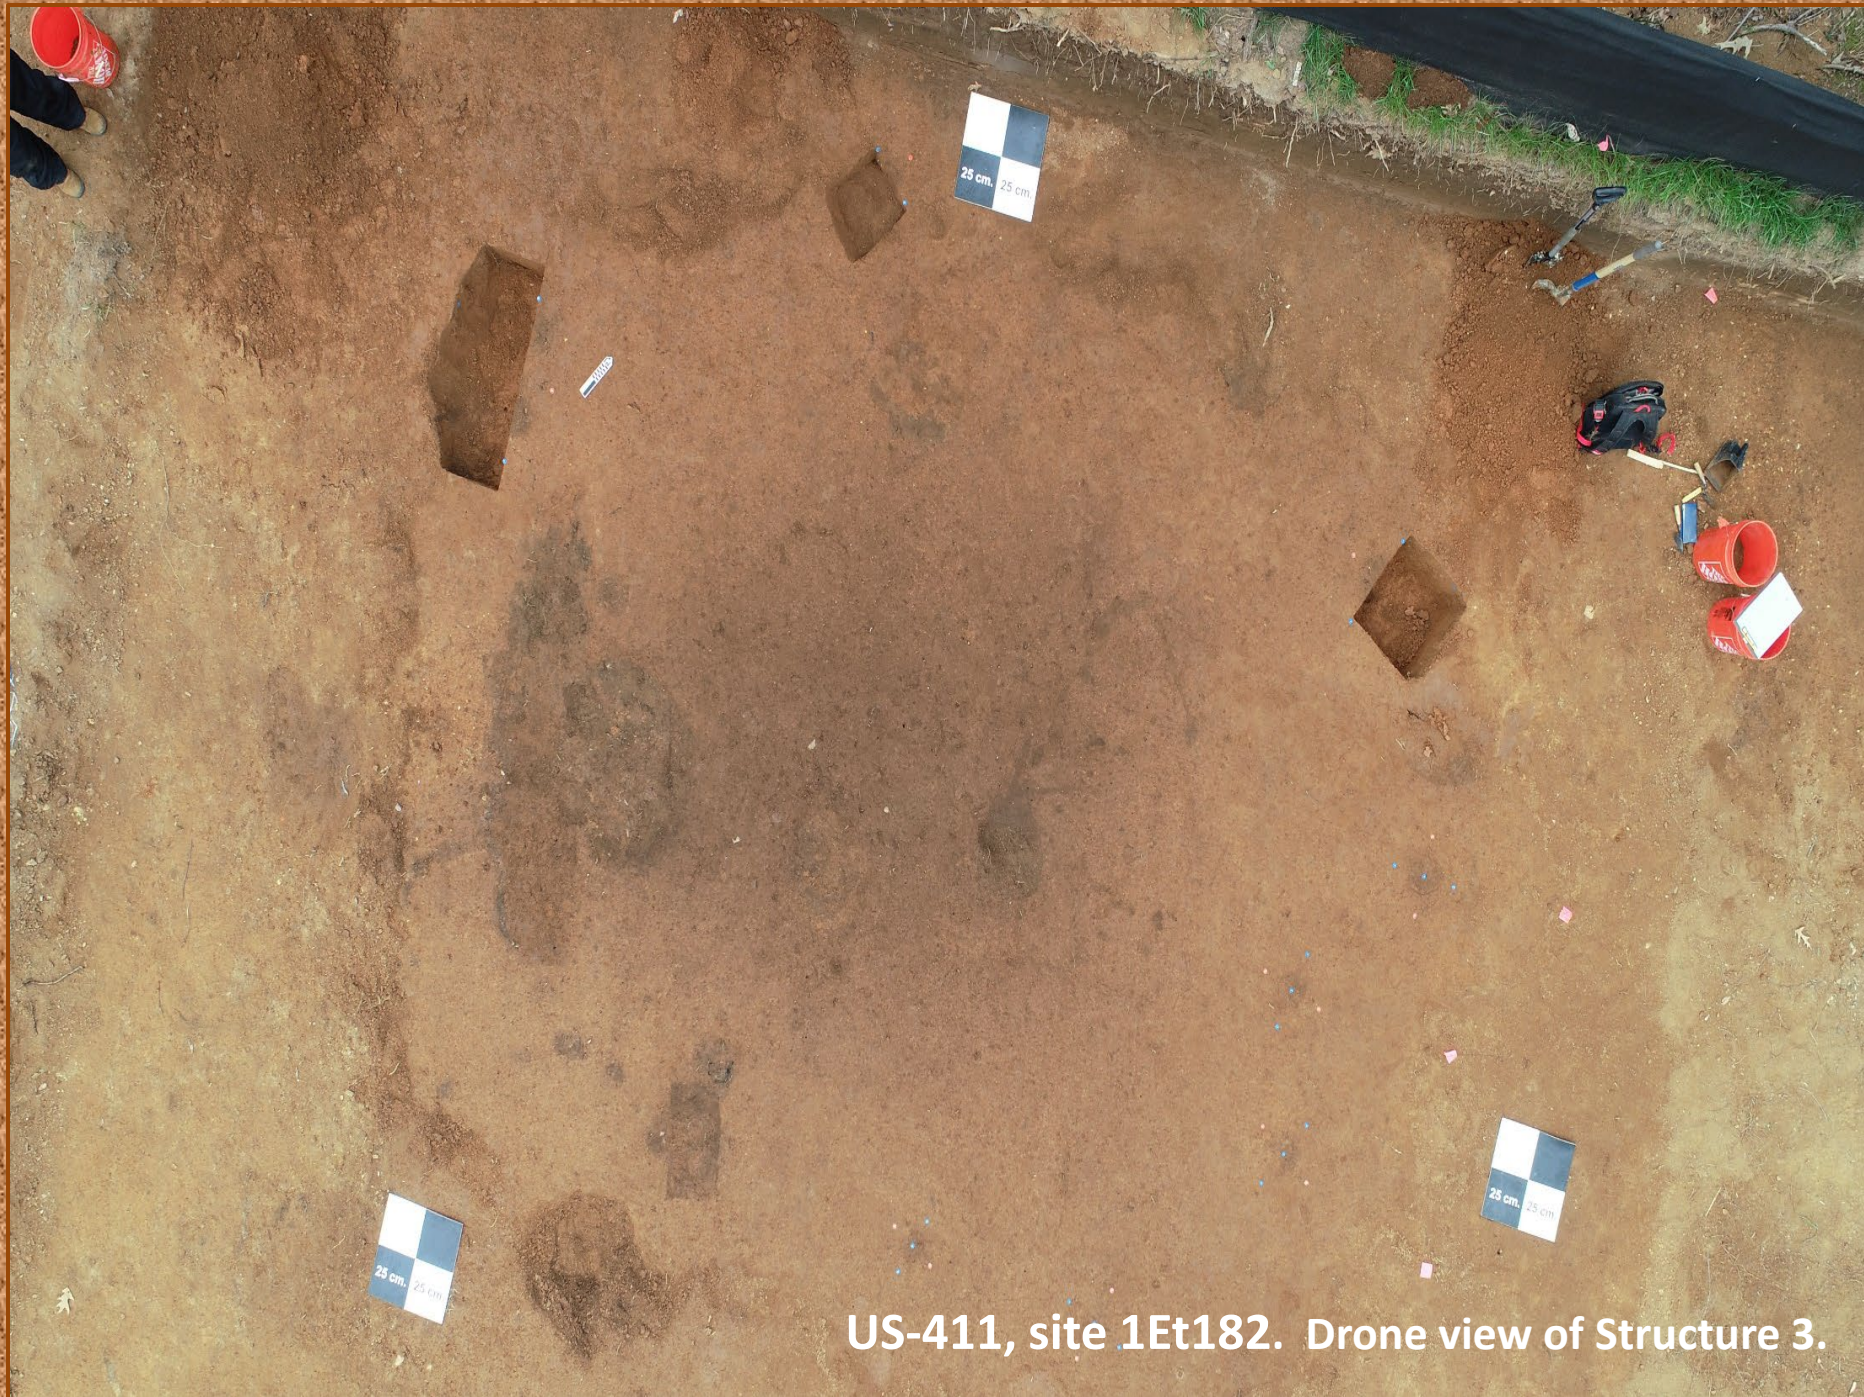
US-411, site 1Et182. Drone view of Structure 3.

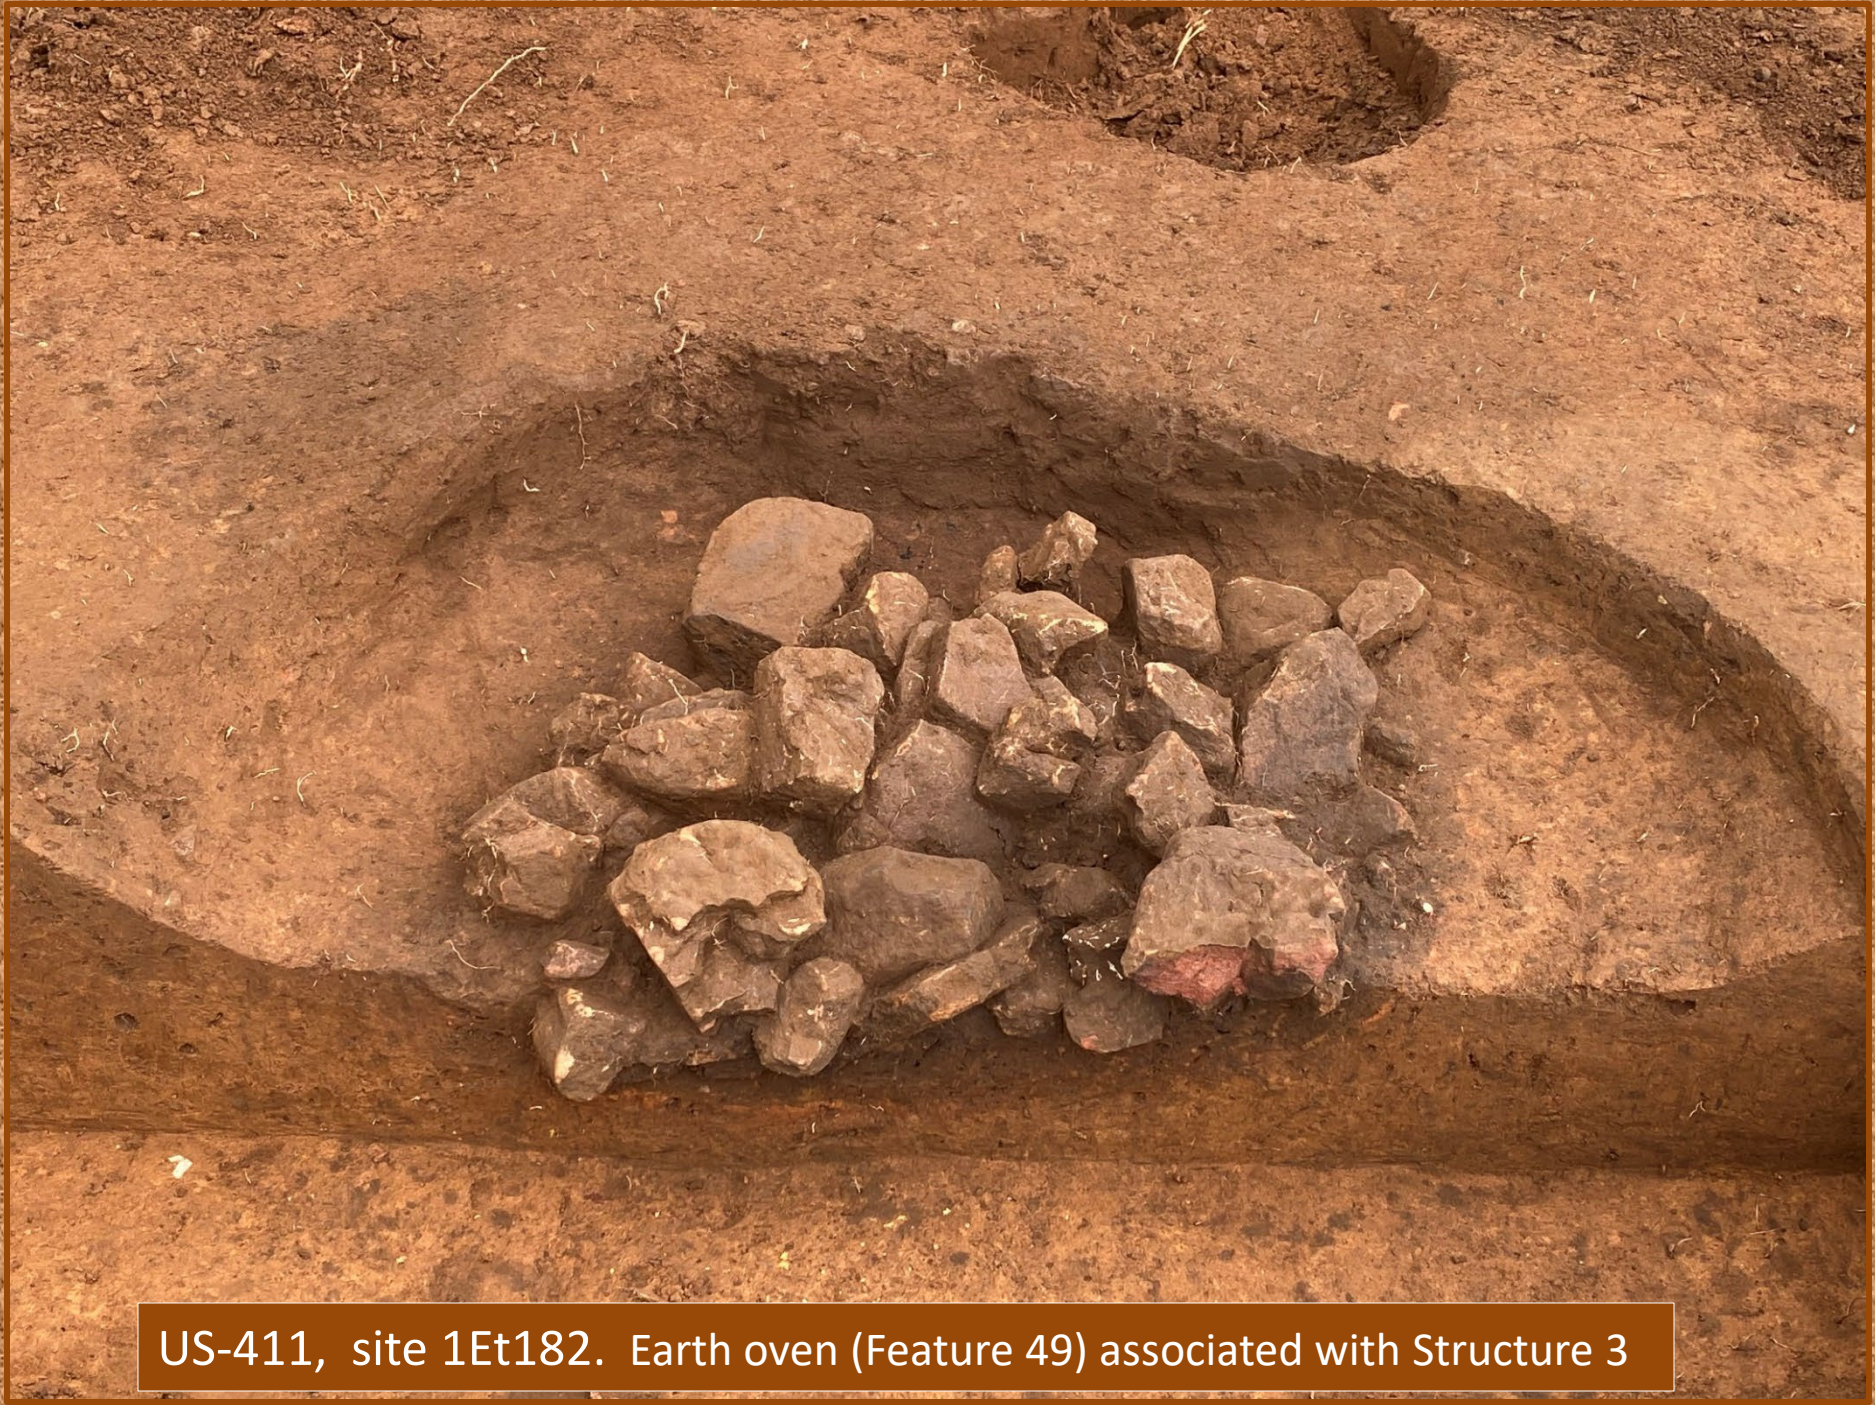
US-411, site 1Et182. Earth oven (Feature 49) associated with Structure 3

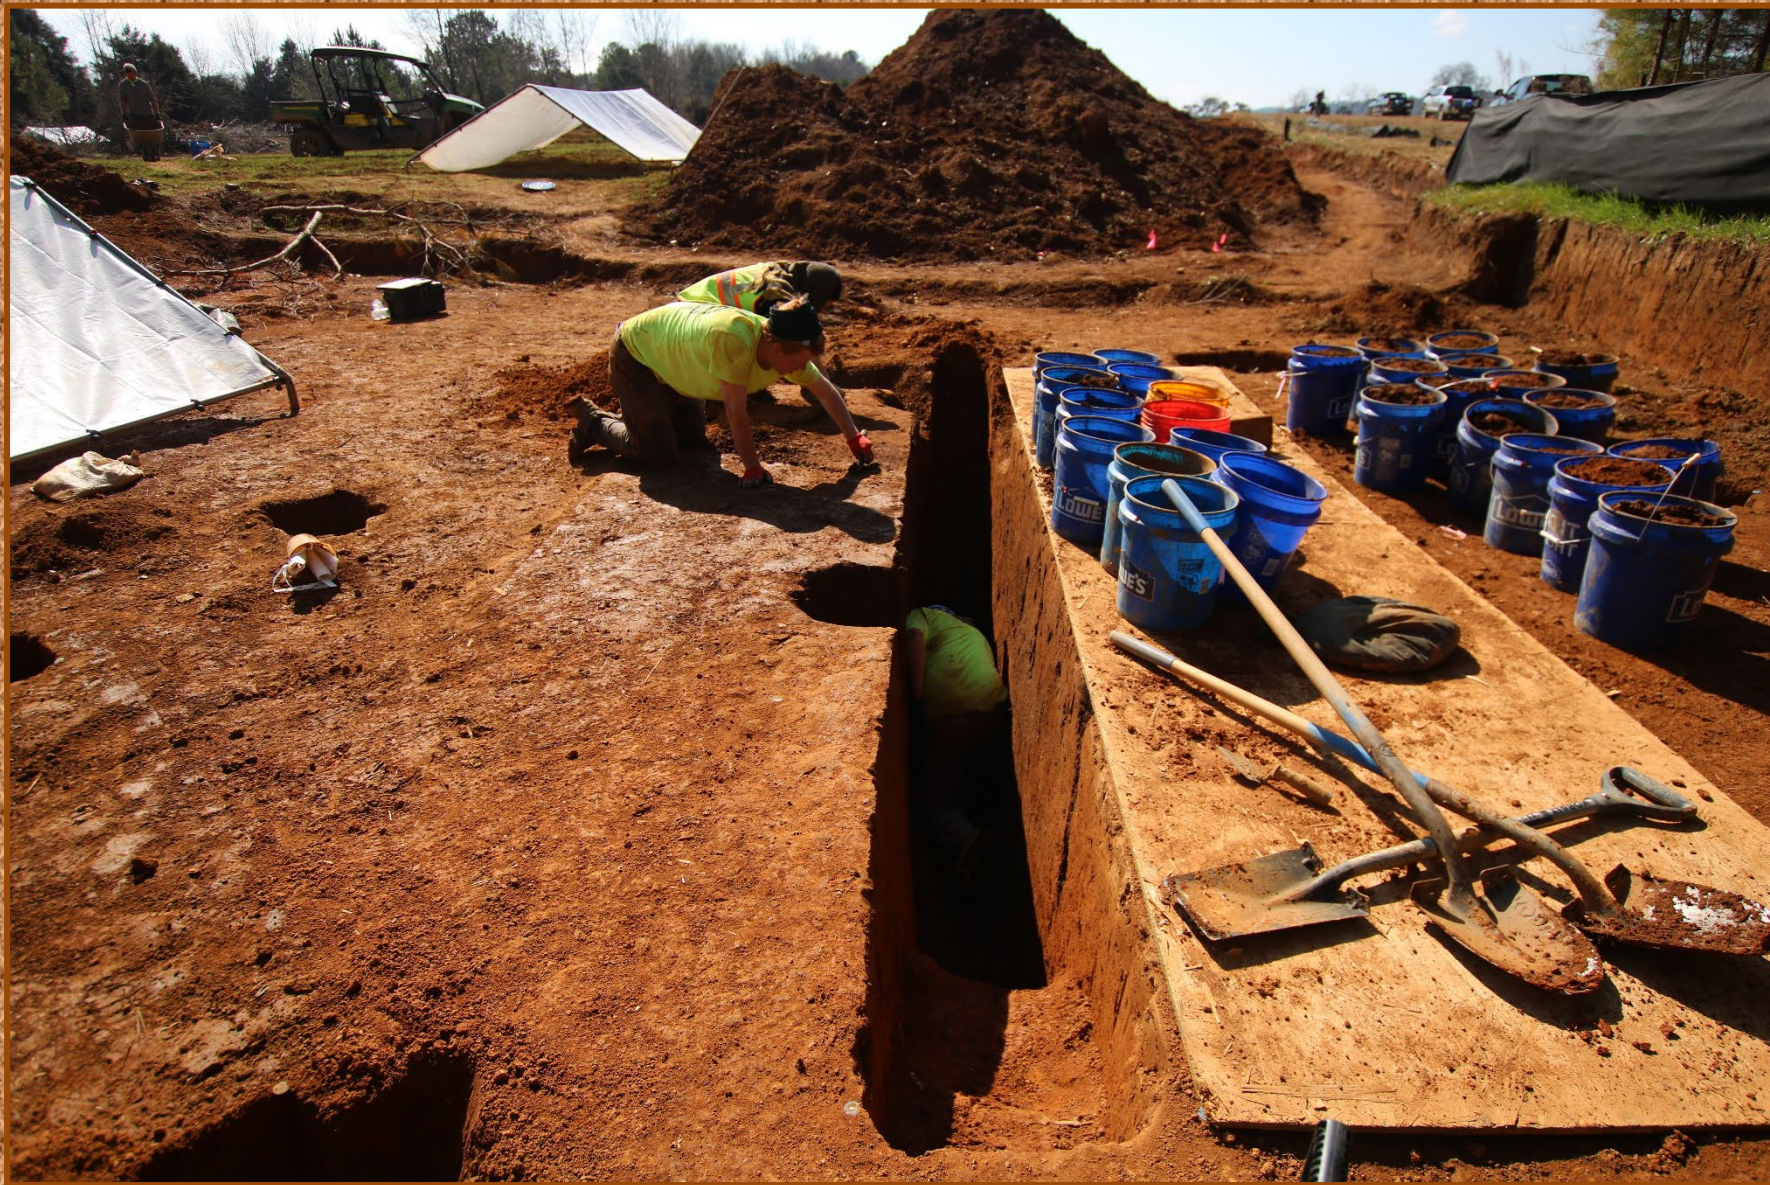
US-411, 1Et182. Stratigraphic test trench through center of Structure 3. View to W.

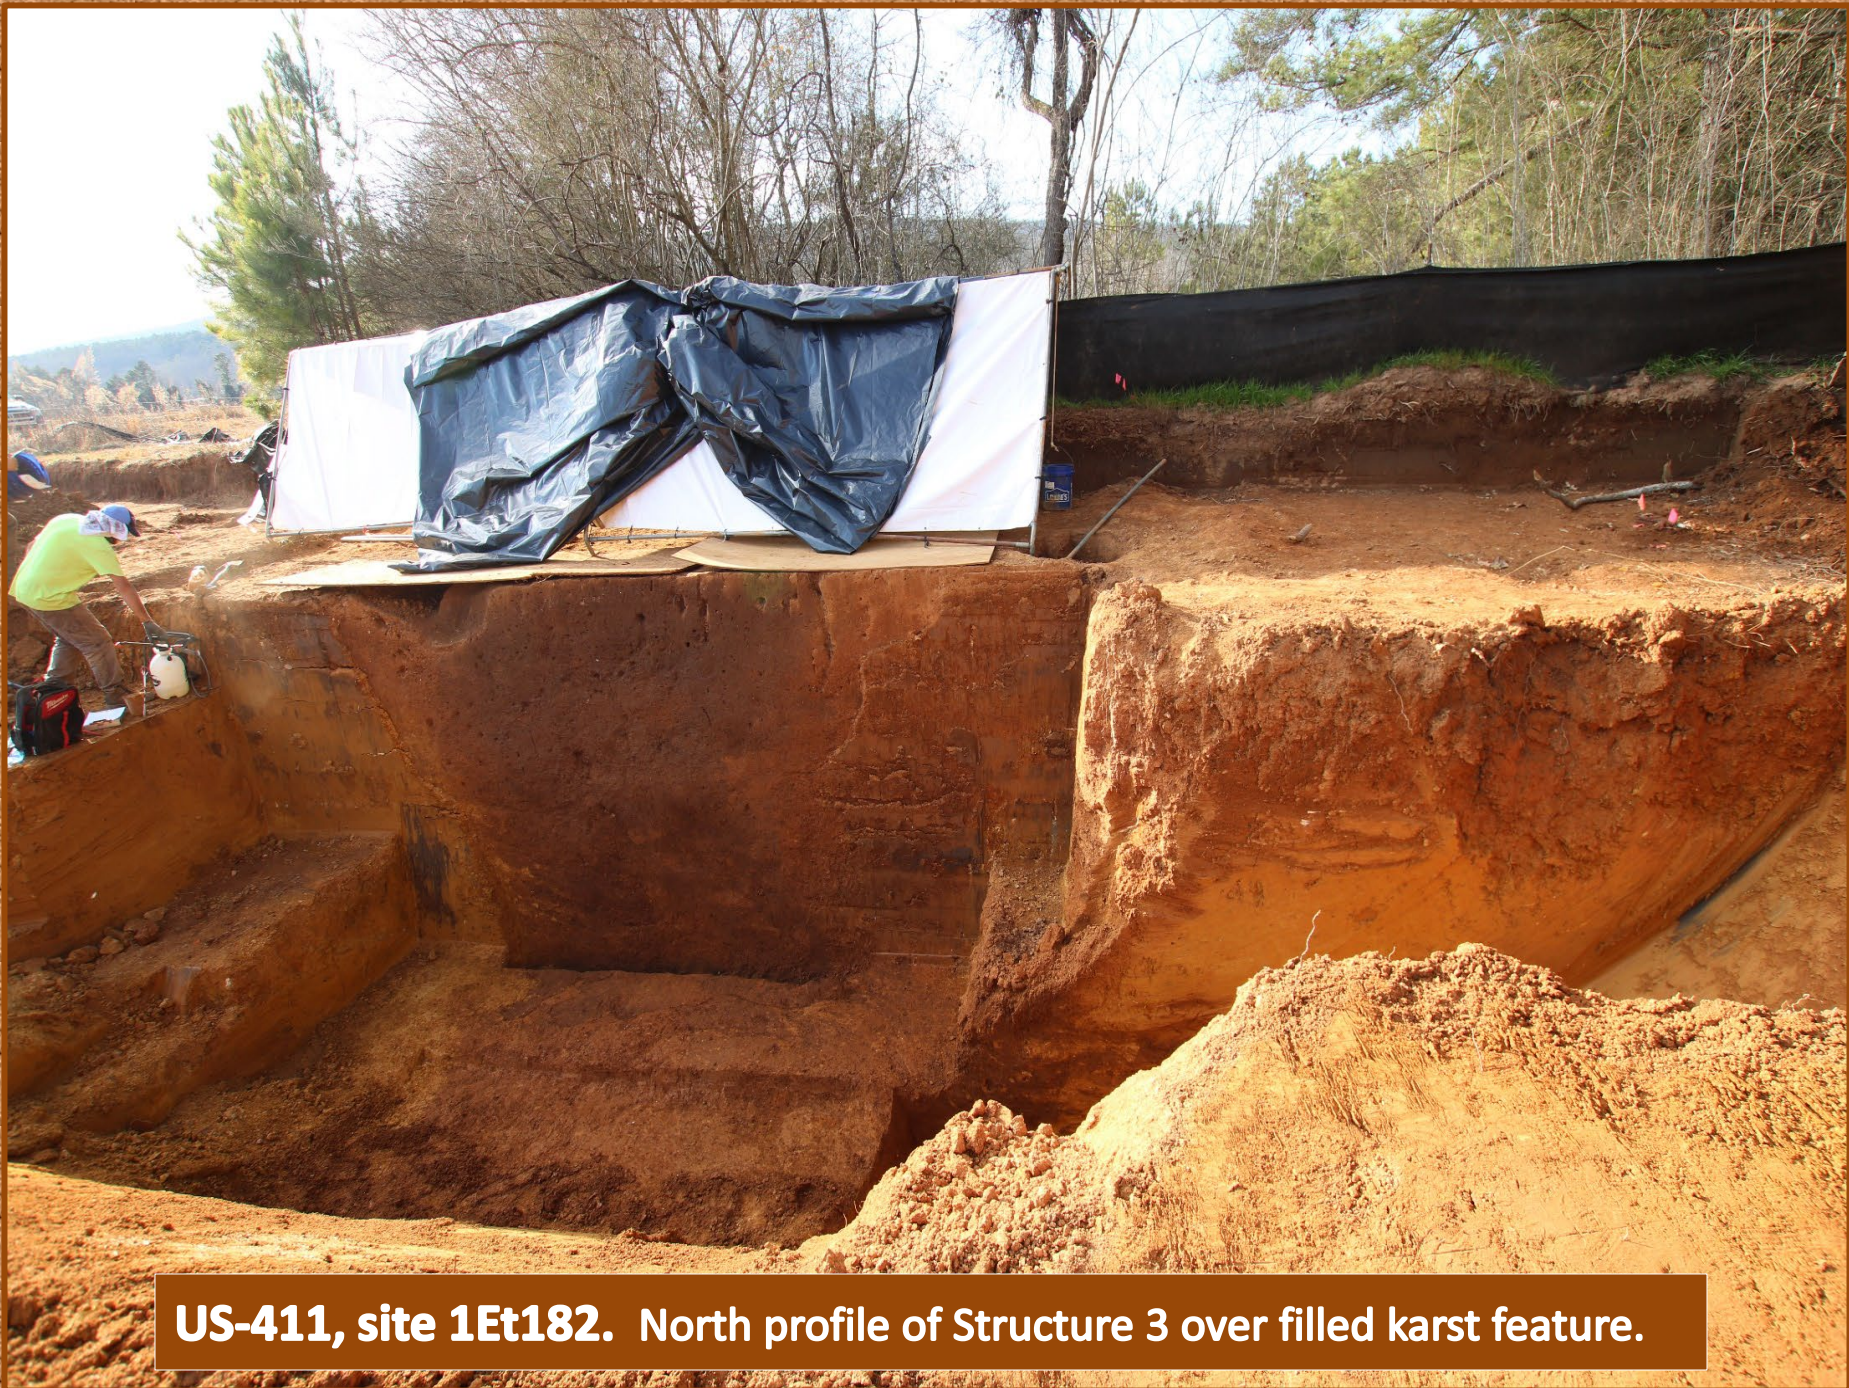
US-411, site 1Et182. North profile of Structure 3 over filled karst feature.

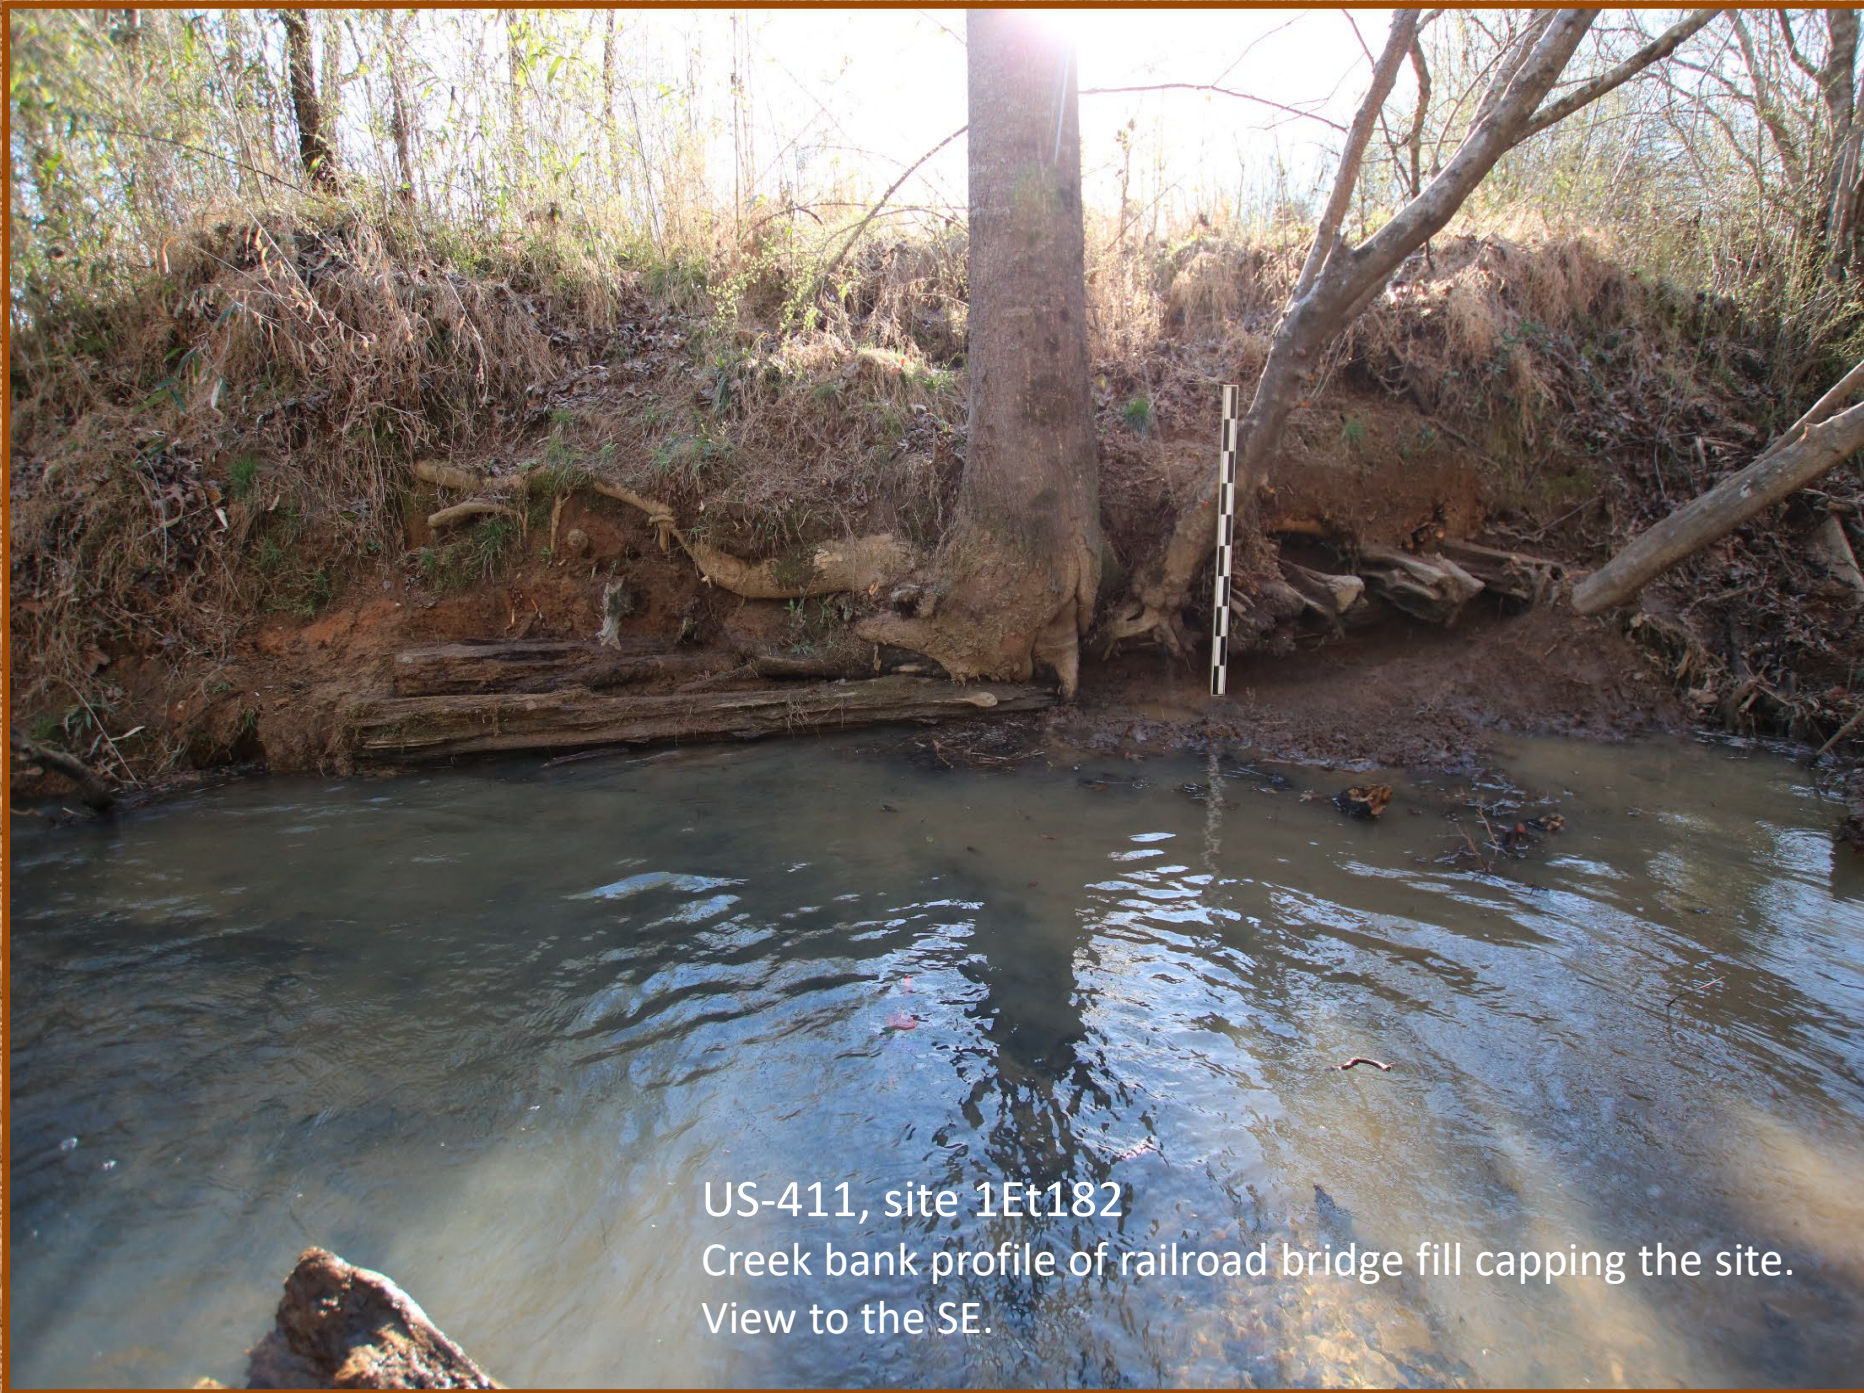
Creek bank profile of railroad bridge fill capping the site.
View to the SE.

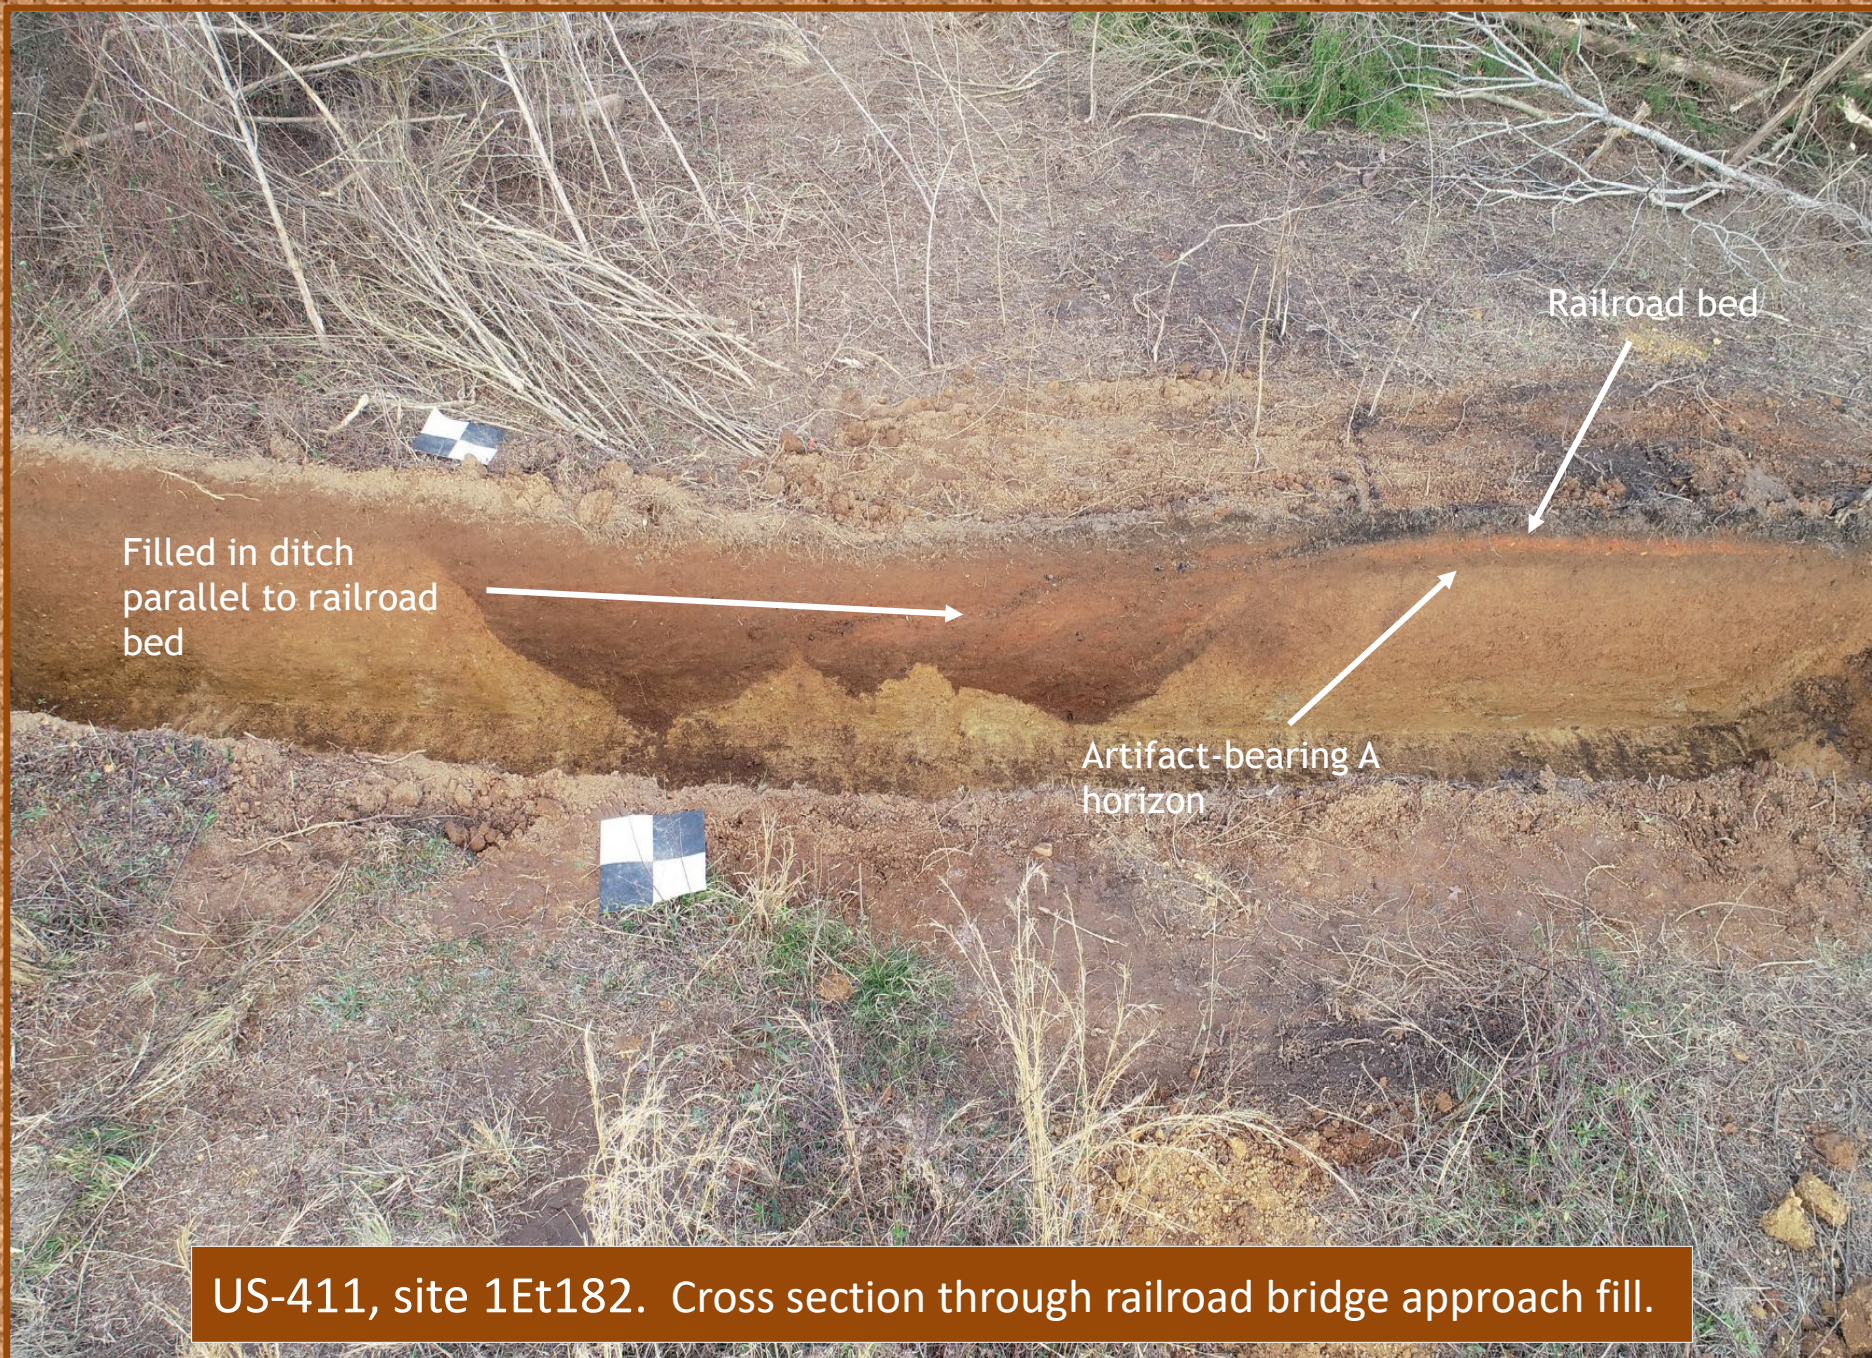
US-411, site 1Et182. Cross section through railroad bridge approach fill.
