US-411

An Archaeological Process

LANE ADDITIONS TO SR 25 (US 411) FROM TURKEYTOWN IN ETOWAH COUNTY
TO .65 MILES NORTH OF COUNTY ROAD 20, CHEROKEE COUNTY, AL
FEDERAL-AID PROJECT NUMBER STPAA-0137(010)

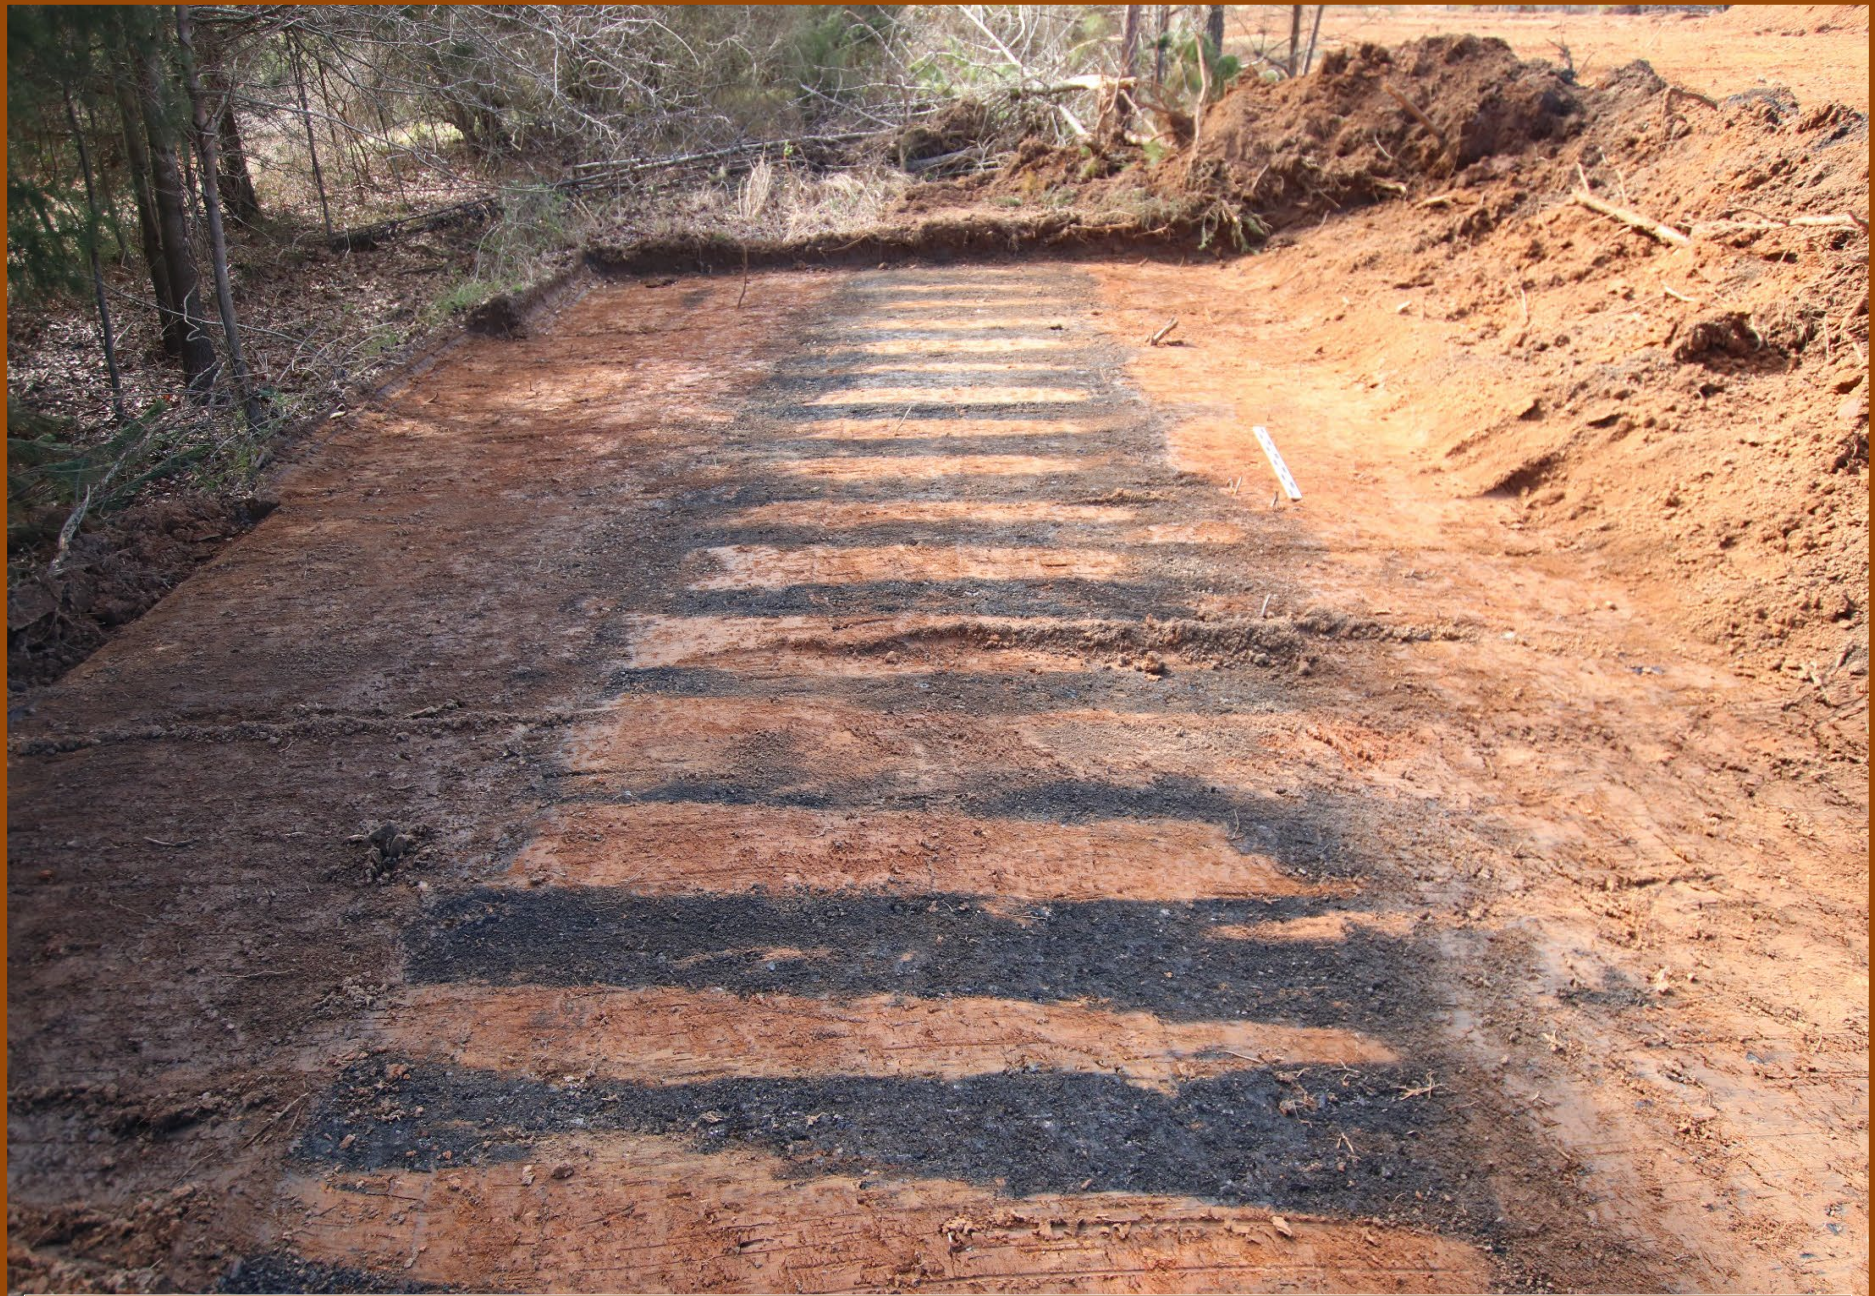
US-411, site 1Et182. Former rail bed showing location of salvaged cross ties . Looking SE.

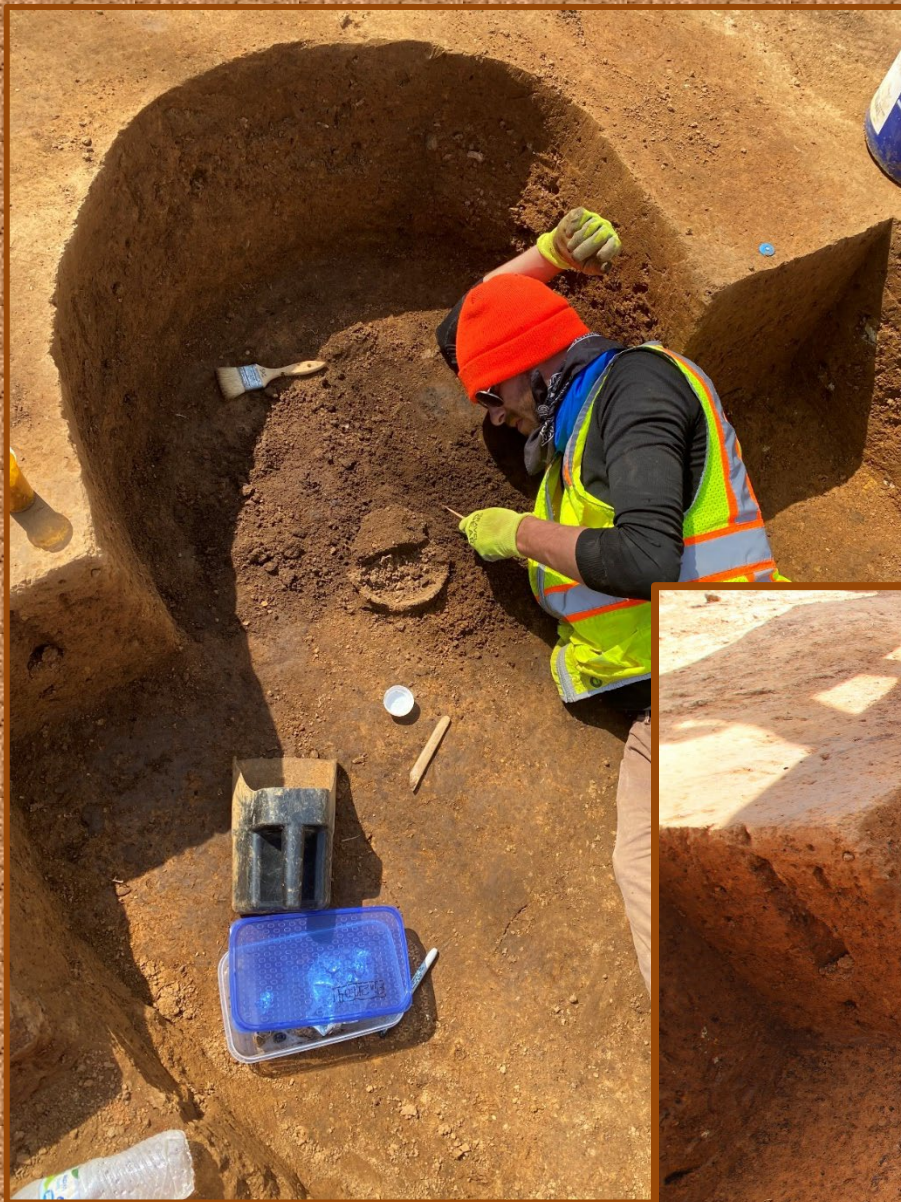
US-411, 1Et182.

Example of features preserved
beneath early historic rail bed
approach fill.
